# MONTANA HISTORICAL AND ARCHITECTURAL INVENTORY

Address: <u>5th Street West</u>	Addition	
Ownership: name: <u>Mary E. Gunnels</u> <input checked="" type="checkbox"/> private <input type="checkbox"/> public		
address: <u>2407 Amarillo Boulevard, Amarillo, Texas</u>		Roll # <u>B3</u> Frame # <u>13</u>

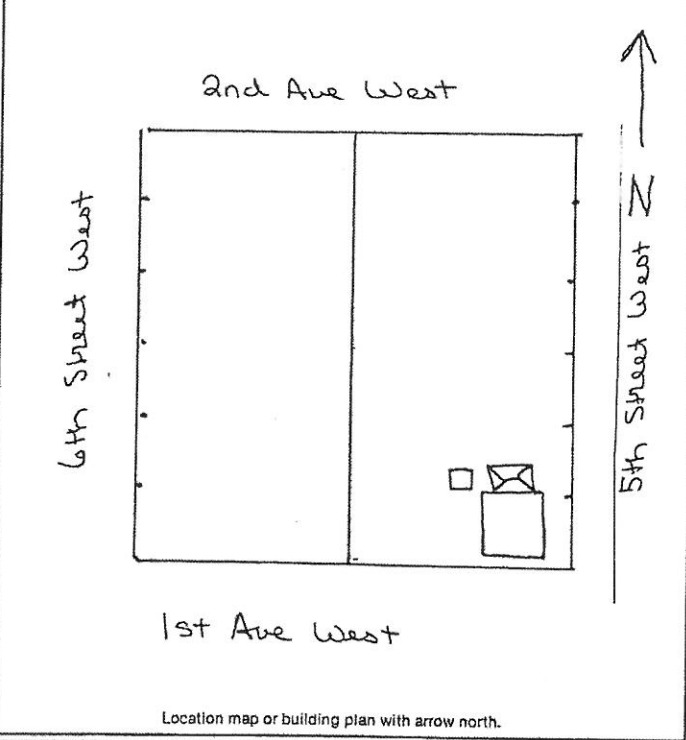
A one-story, wood-frame residence (attached to the First Street West Garage), with front hip and rear gable roof, front porch, beveled siding, and a pier and post foundation. Roof has interlocking T-shaped composition shingles, stove pipe, and metal roof ridges. Windows are wood-frame double-hung, with wood surround trim. Doors are wood with panels and lights. Front porch has shed roof with several in-line double-hung windows and has small covered entryway attached to it. Rear of building was extended about 7 or 8 feet and has wide board siding with plywood and bottom on rear gable. Small porch with shed roof is attached to the rear of the structure. Small shed with shed roof and horizontal board siding is located just to the rear of the residence. The residence was moved to this location during the 1920's.

Residence is located in block of other small and older residences and is generally compatible with them. Movement of building to present location has caused a loss of integrity of location, and rear addition has caused a loss of integrity of design, and attachment to back of garage has caused a loss of integrity of setting.
