# MONTANA HISTORICAL AND ARCHITECTURAL INVENTORY

Legal Description: Block 2, Lots 7 & 8, Park Addition	
Address: 519 1st Ave. West	
Ownership: name: Larry G. Lekse	Roll # B3 Frame # 16
<input checked="" type="checkbox"/> private address: 519 1st Ave. West, Roundup, Mt.

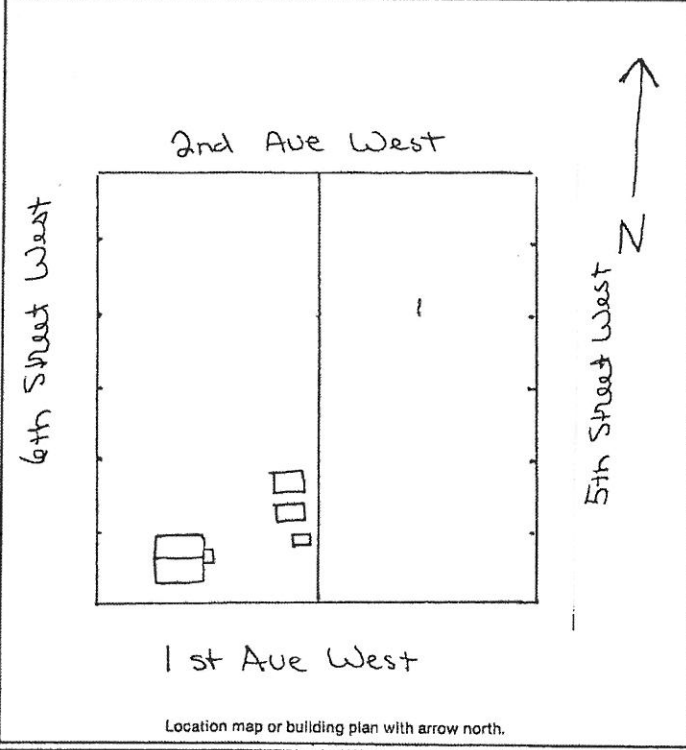
A one-story square, gable roof residence with enclosed front porch, aluminum siding, and concrete foundation. Roof has composition shingles, interior chimney, and eaves with fascia. Windows vary; east side of building & porch have wood frame double hung 1/1, other sides of building have smaller aluminum frame sliding windows without trim. Porch door is wood, with wood frame and single window. Corrugated plastic awning supported by metal posts extends over back patio. Front porch consists of extension of eave and has applied simulated ashlar apron.

Residence is located in block of small older residences and is larger in scale than they are. Its recent addition of aluminum siding, aluminum windows without sills & simulated ashlar porch has caused a noticeable loss of integrity.
