MONTANA HISTORICAL AND ARCHITECTURAL INVENTORY

| Legal Description: <u>Block 4 W 90' of Lots 4 & 5, Park Addition</u> Address: <u>10 Seventh Street West</u> Ownership: name: <u>Hopkins Plumbing and Heating</u> <input checked="" type="checkbox"/> private <input type="checkbox"/> public address: <u>612 First Avenue West, Roundup, MT</u> | Site # _____ | |

| Historic Name: _____ Common Name: _____ Date of Construction: <u>1910</u> <input checked="" type="checkbox"/> estimated <input type="checkbox"/> documented Architect: _____ Builder: _____ Original Owner: <u>Elizabeth Liddell</u> Original Use: <u>boarding house</u> Present Use: <u>storage-plumbing</u> |

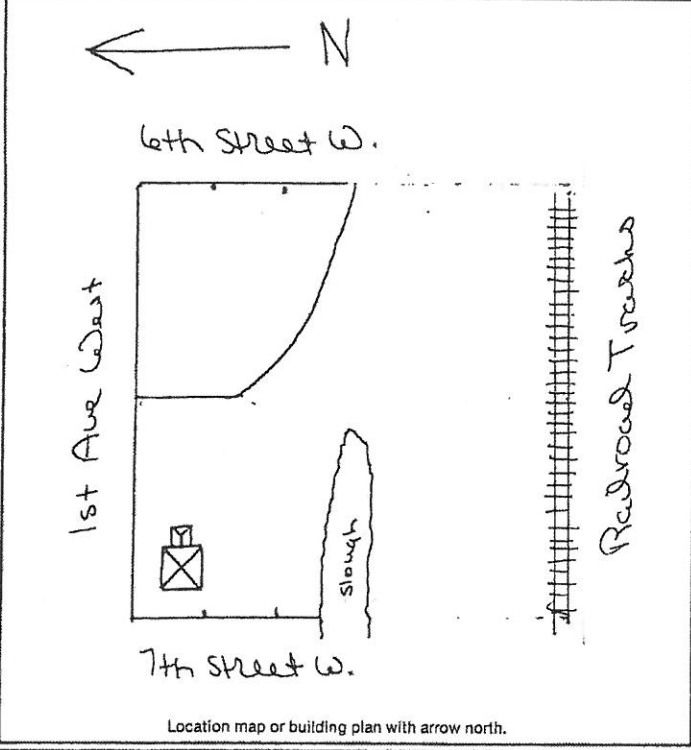
| Roll # <u>A4</u> Frame # <u>14</u> | | |

This square two story wood frame large commercial building has a clipped hip roof, small enclosed eaves and a decorative trim on the edge of the clipped roof. Other features include beveled edge wood siding with corner boards and eaves trim boards, wood surround and sill for boarded up windows, wood paneled door with glass gone, and carved wood scroll design. There is a cement foundation. Modern materials include asphalt roofing, and a large casement hung rough timber doorway cut into the south side of the building.

An interesting architectural feature is the two story clipped hip roof design of the building. The only example of this in the study area. This is a contributing structure.

This tall residence-storage building is at the edge of town right on the main highway. Despite the storage entrance in the southside of this structure, and the boarded up windows, this building retains design, craftsmanship and materials integrity.
