# MONTANA HISTORICAL AND ARCHITECTURAL INVENTORY

Legal Description: <u>Block 2, all Lot 4, and 8 1/2 Lot 3, Park Addition</u> Address: <u>109 Fifth Street West</u> Ownership: name: <u>Fred Tressl et al.</u> <input checked="" type="checkbox"/> private <input type="checkbox"/> public address: <u>109 Fifth Street West, Roundup, MT</u>	Site # _____

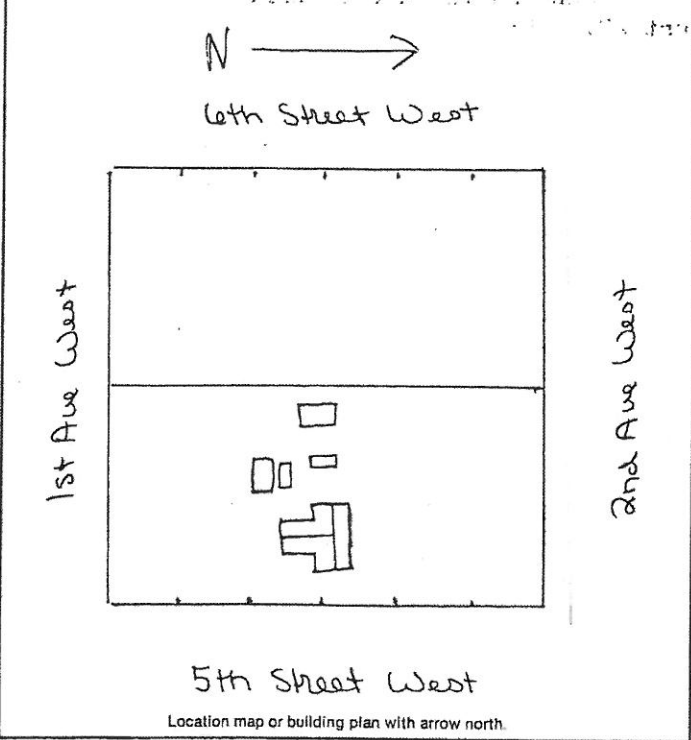
Roll # <u>B3</u> Frame # <u>12</u>

**One story, wood-frame, T-shaped residence with intersecting gables; layered gable-rear extension front porch and a concrete foundation. Roof is wood shingle, has an interior chimney, and extending eaves with fascia. Building has beveled siding with end boards. Windows are wood frame double hung 1/1 with wood surround trim. Doors are wood frame wood with panels and lights, and wood surround trim.**

Residence has wood frame garage with wood shingle roof and clapboard siding. Garage has flat roof extension on north side. A-frame sheds with shed roofs, with masonite siding is located at the rear of the property, along with a covered patio.

Kitchen addition was constructed in the 1920's.  
 This is a contributing structure.
