MONTANA HISTORICAL AND ARCHITECTURAL INVENTORY

Address: 110 Seventh Street West

Date of Construction: 1920 Moved in and Remodeled, 1930 estimated documented

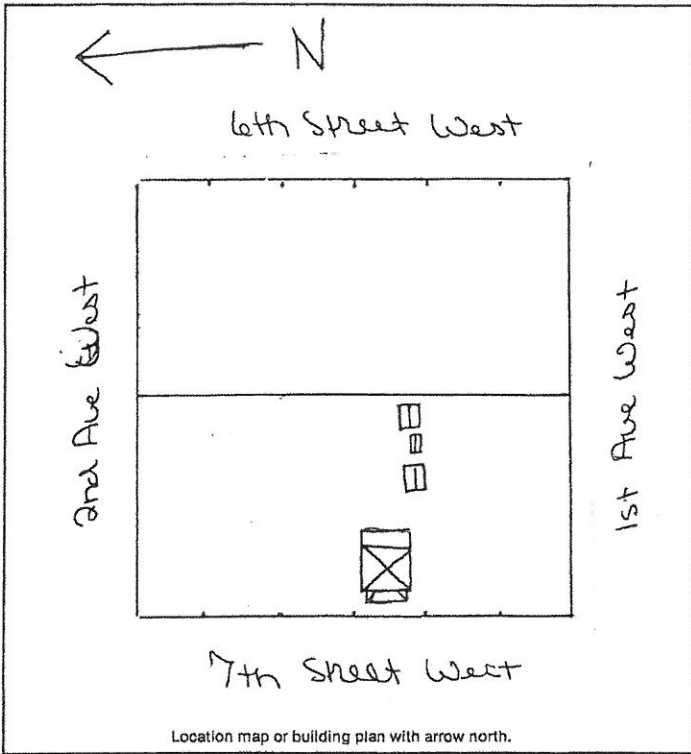
Roll # A4 Frame # 21

This one-story, square, wood-frame residence has a pyramid hip roof, a shed roof rear addition, a hip roof enclosed seven-eighths front porch, and a hip roof dormer. Other features include a central stretcher bond brick chimney, extended enclosed eaves, narrow 1/1 double-hung row windows in the enclosed porch, leaded multilight fixed rectangular windows to the south, a sealed dormer window with air vent, cement foundation. Modern materials include asphalt roofing, steel siding, cement stoop with iron rail and modern wood door.

Outbuildings include, 1. A medium sized rectangular gable roof garage with asphalt roofing, steel siding, fixed rectangular windows, double four-light wood panel rising garage door and a cement slab foundation. 2. A small one-story rectangular wood frame building with gable roof, asphalt roofing, beveled edge wood with corner boards, short eaves, wood panel door, no foundation. 3. A rectangular gable roof with shed roof side addition storage shed with asphalt roofing, horizontal rough timber siding, vertical timber casement hung garage doors, and no foundation.

This mine house is located on the edge of town, a few houses and a horse pasture across the street, and smaller older homes in the block. This moved in house has lost some integrity of material due to steel siding and asphalt roofing, but still retains excellent integrity of design and craftsmanship. This is a representative relocated mine house.
