MONTANA HISTORICAL AND ARCHITECTURAL INVENTORY

Address: <u>111 5th Street West</u>			
Ownership: name: <u>Fred Tressl et al</u>			
<input checked="" type="checkbox"/> private <input type="checkbox"/> public	address: <u>109 5th Street West, Roundup, Mt.</u>	Roll # <u>B3</u> Frame # <u>11</u>

Historic Name: _____
Common Name: _____
Date of Construction: <u>1913 or 1914</u> <input type="checkbox"/> estimated <input checked="" type="checkbox"/> documented
Architect: _____
Builder: <u>Fred Tressl</u>
Original Owner: <u>Fred Tressl</u>
Original Use: <u>residence</u>
Present Use: <u>residence</u>
Research Sources:
<input type="checkbox"/> abstract of title <input type="checkbox"/> city directories
<input type="checkbox"/> plat records/maps <input type="checkbox"/> sewer/water permits
<input checked="" type="checkbox"/> tax cards <u>1920</u> <input type="checkbox"/> obituaries
<input type="checkbox"/> building permit <input type="checkbox"/> biographies
<input checked="" type="checkbox"/> Sanborn maps — dates: <u>1920; before 1920</u>
Bibliography:
<u>Interview: Fred Tressl</u> <u>July 14, 1983</u> <u>Chain of Ownership cards, Clerk and Recorder's Office</u>

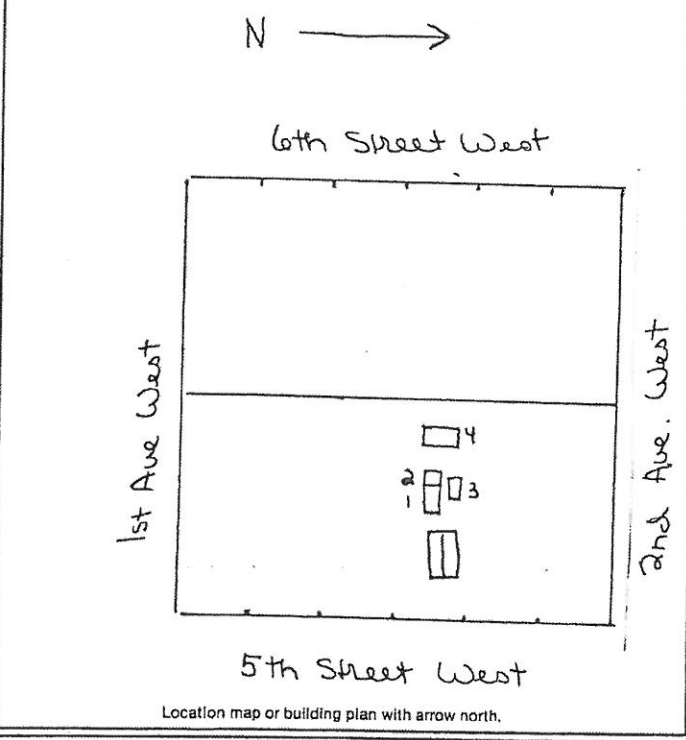
A small one-story wood frame residence with gabled roof, front porch, and concrete foundation. Roof has composition shingles, interior chimney and extending eaves with fascia. Building has clapboard siding with end boards. Windows are wood-frame, double hung 1/1 with wood surround trim. Open front porch has hipped roof, lathed support posts and railing. Rear porch has \wedge shaped roof with wood shingles and corrugated plastic siding about 3/4 of the way to roof line.

Several sheds are located at rear of property, all have shed roofs. 1 has horizontal board siding with elbow stove pipe extending from North end. 2 & 3 have composition siding. 4 has simulated ashlar composition siding.

This building is located in a block of other small, older residences. It possesses integrity of setting, design, materials, and workmanship and clearly conveys its historical associations.
