# MONTANA HISTORICAL AND ARCHITECTURAL INVENTORY

Address: 111 6th Street West

Date of Construction: 1910 Remodeled 1947  estimated  documented

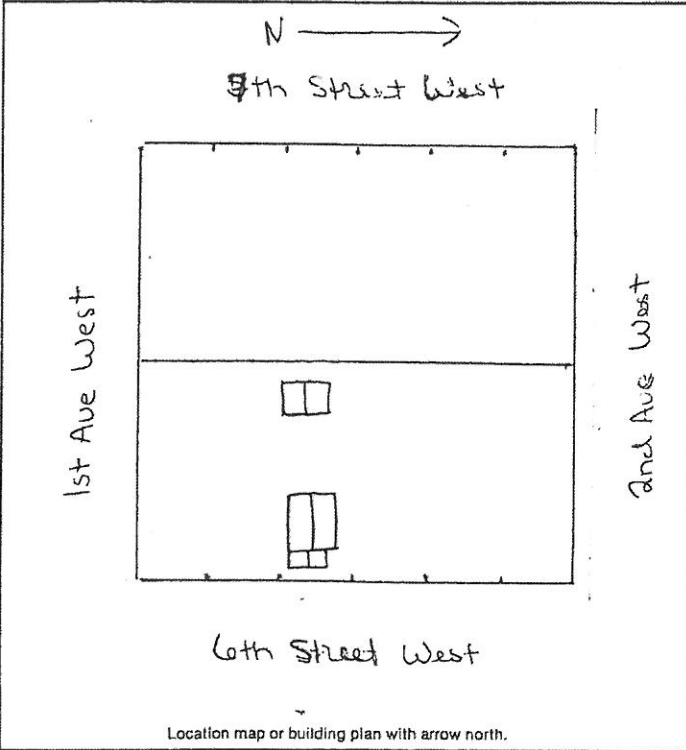
This one-story rectangular wood-frame residence has a gable roof facing the street, and a large gable roof enclosed three-fourths porch. Other features include a stretcher bond brick interior chimney, asphalt roofing, wide aluminum siding, 2/2 double-hung windows, and a twelve-light rectangular fixed window to the south. The enclosed porch has horizontal 1/1 fixed rectangular wood-frame windows and a wood panel and glass door with two cement steps to the porch. The foundation is coarsed sandstone block and cement under the porch.

There is a large new two-car gable roof garage in the rear of the property with asphalt roofing, overhung eaves with boxed eaves returns, aluminum window frames, two rising paneled double doors with four lights in each and a cement slab foundation.

This remodeled residence is located in a quiet neighborhood near the main highway with mostly smaller, older homes. The addition of the very large enclosed front porch with more modern wood windows in the late 40's, has caused loss of design integrity, and modern siding and windows has caused loss of materials integrity.
