# MONTANA HISTORICAL AND ARCHITECTURAL INVENTORY

Address: 112 Seventh Street West

Date of Construction: 1917 Remodeled 1942  estimated  documented

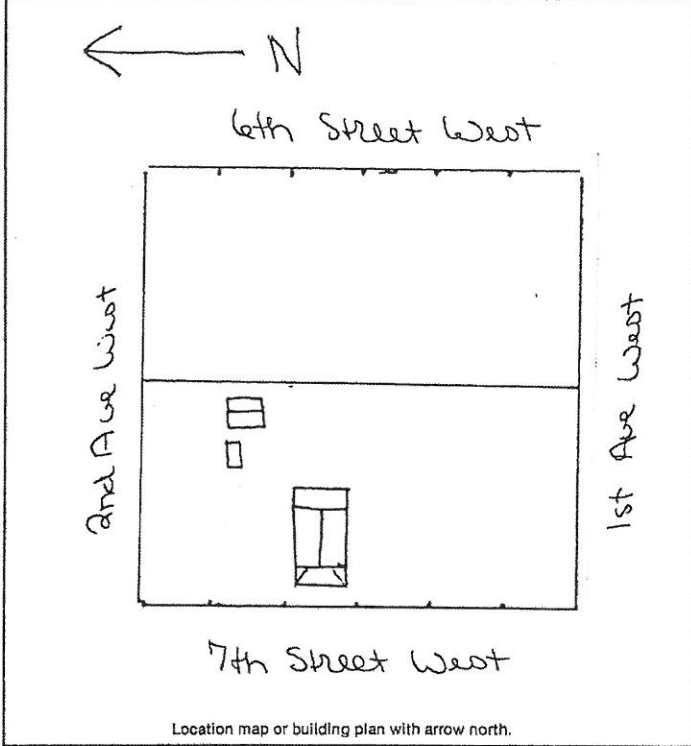
Roll # A4 Frame # 22

This one-story, wood-frame rectangular residence has a gable roof with hip roof section-eighths open front porch and a shed roof rear addition. Other features include an interior brick chimney, extended eaves with purlins, exposed rafters, stucco siding, 1/1 double-hung and two large ten-light fixed windows, and a plain wood door. The open porch has squared stuccoed porch supports, solid stucco railing with a flat board sill, and a cement porch floor and step.

Modern materials are the asphalt roof shingles.

Outbuildings include 1. A large gable roof garage with asphalt shingles, wood shingle siding, extended eaves with diagonal braces and purlins, corner boards, exposed rafters, two casement hung wood garage doors, wood side door in surround, interior brick corbeled chimney, no foundation 2. A shed roof wood frame shed with wood shingle siding, wood foundation, two wood surround wood plank doors (perhaps an old outhouse).

This house is located in a block of older, predominantly remodeled residences, near the main highway into town. This house retains good integrity of design, materials and craftsmanship.
