MONTANA HISTORICAL AND ARCHITECTURAL INVENTORY

Address: 115 Sixth Street West

Common Name: after remodeled

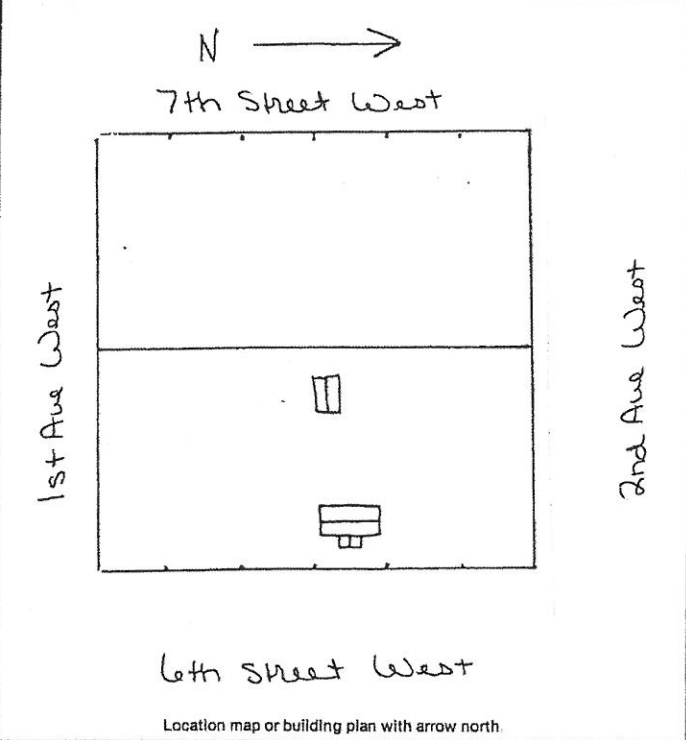
Roll # A4 Frame # 17

This small one story wood frame residence has a gable roof and a gable semi-enclosed street level 1/2 front porch. Other features include a brick stretch stretcher bond interior chimney, stepped molded eaves, beveled edge wood siding with corner boards, 1/1 double hung window with wood surround drip board, sill and an over size 1/1 fixed window. The gable semi-enclosed porch has stepped molded eaves, beveled edge wood siding below the window, plain board siding above, and plastic covering in the porch window area. Modern materials are the plastic porch covering, and asphalt roof shingles.

There is a wood frame gable roof garage to the back of the property with wood roof shingles, rough cut lumber board and batten siding, corner boards, exposed rafters, vertical board door, casement hung garage doors of board and batten siding, and no foundation.

An interesting architectural feature of this small plain house is the stepped molded eaves.

This quite small house is located in a quiet working class neighborhood, of many remodeled homes. This little house was remodeled in the early 30's with a back room added and a gable roof added (it used to have a flat roof) and sandstone basement. The asphalt roofing and plastic window covering causes some loss of materials integrity, but basic integrity of design, materials and craftsmanship is still retained.
