MONTANA HISTORICAL AND ARCHITECTURAL INVENTORY

Legal Description: **Block 2, Lot 11, Park Addition**

Address: **118 Sixth Street West**

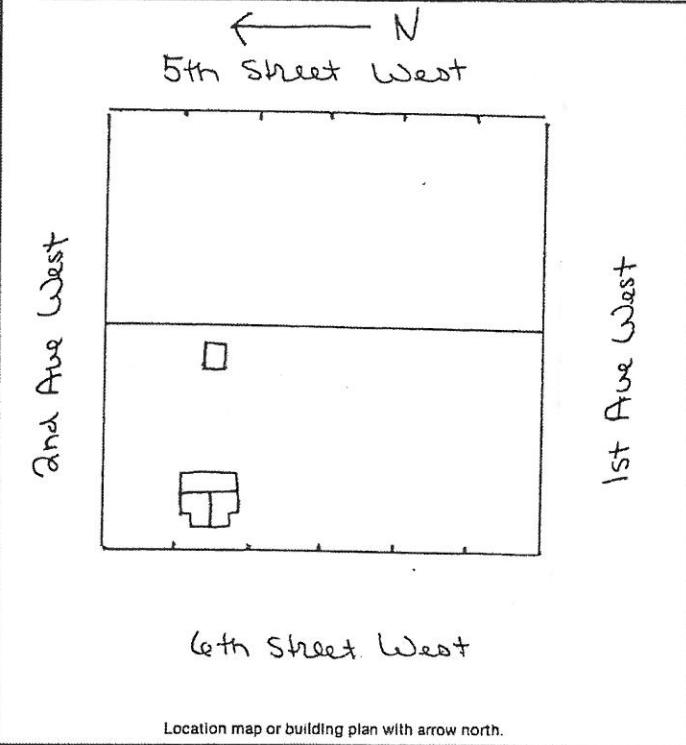
Roll # B3 Frame # 19

A one-story T-shaped wood-frame residence with intersecting gables, horizontal beveled siding, enclosed front porch and concrete foundation. Residence has large shed roof addition in the rear added in 1965. Roof has T-shaped corbeled chimney, wood shingles, eaves with molding and rafters. Siding is horizontal-beveled and has end boards. Windows are wood-frame, with wood-surround trim, and double hung 1/1. Windows to the side of the building are sliding, with wood frames, some with alluminum casings. Exterior cinder chimney is located on north side of building. Front porch has several in line double hung windows on open of wood siding.

Small roofed shed with horizontal beveled siding, fixed windows with wood surround trim and composition sheet foof is located at rear of property.

Building is located in block of other small, old residences. Large shed roof addition on structure in 1965 has caused a loss of integrity of design, although similar materials were used.
