MONTANA HISTORICAL AND ARCHITECTURAL INVENTORY

Legal Description: Block 5, Lot 1, Park Additon
 Address: 121 Sixth Street West
 Ownership: name: Harry and Audrey Kowalczyk
 private public address: 121 Sixth Street West, Roundup, Mt.

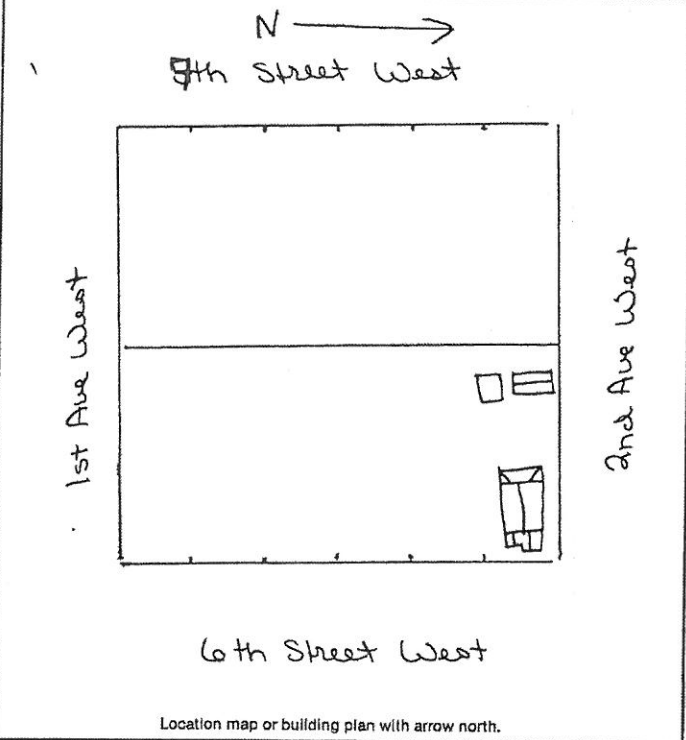
Roll # A4 Frame # 15

This one story wood frame rectangular residence has a gable roof, a gable bay, a gable porch, and a hip roof rear addition. Other features include stretcher bond interior brick chimney, elongated eaves with purlins, exposed rafters, an enclosed 1/2 front porch, 6/1 double hung windows, and a flared exterior wainscoating. The exterior "skirt" is a different color siding. There is a two step cement stoop, and cement foundation with cement surround to basement windows and coal chute. Modern materials include asphalt roof shingles, aluminium slide porch windows, and asphalt siding.

Outbuildings include (1) a rectangular wood frame garage-workshop with gable roof, wood shingle siding, asphalt roofing, wood casement hung shutters, with wood sill, enclosed wood doorway, and wood entry (perhaps an old stable). (2) A square wood frame gable roof shed with asphalt roofing, horizontal wood siding above the windows, vertical siding below, continuous sill around the building, fixed rectangular windows in wood surround, 6 light and wood panel door, no foundation and corrogated fiberglass awning. No foundation.

The flared "skirt" is an architectural detail that several houses in the area still have.

This house is located in a quiet, older working class neighborhood, some homes remodeled, some not. The remodeled porch windows and asphalt siding has caused some loss of integrity, but the triple gable front design and flared wainscoating retains basic integrity of design and craftsmanship.
