MONTANA HISTORICAL AND ARCHITECTURAL INVENTORY

Address: 123 5th Street Southwest		
Ownership: name: Tony Lekse		
<input checked="" type="checkbox"/> private <input type="checkbox"/> public address: 120 6th Street West, Roundup, Mt.	Roll # B3	Frame # 10

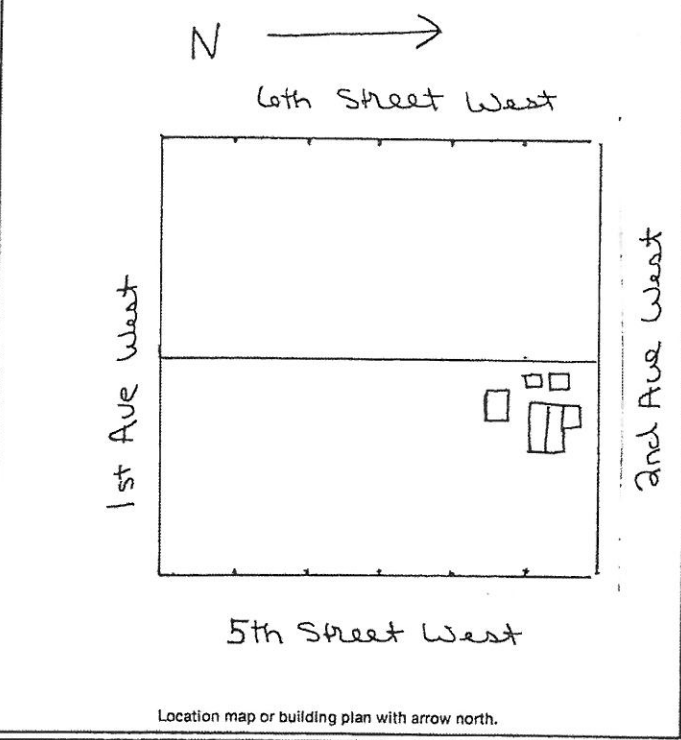
A one-story ell-shaped wood-frame residence with truncated hip roof, rear hip roof extension, side shed roof extension and concrete foundation. The building was moved to the present site in the 1920's and the alterations constructed afterwards. Roof to main structure has wood shingles; roof to rear extension has composition shingles and roof to shed roof extension has composition sheets. Building has wood frame, double-hung windows with wood-surround trim. Door is wood frame, with panels and lights. Siding is steel or aluminium.

Wood-frame, gable roof garage with composition siding, wood-frame shed with gable roof, composition siding and roof extension, and square wood-frame with corrugated metal siding are located at rear of property.

This building is located in a block of other small, older residences. It was moved to the location in the 1920's. Its several additions and use of metal siding have caused a loss of integrity of design and workmanship.
