MONTANA HISTORICAL AND ARCHITECTURAL INVENTORY

Address: 124 Seventh Street West

Date of Construction: 1920 Remodeled estimated documented

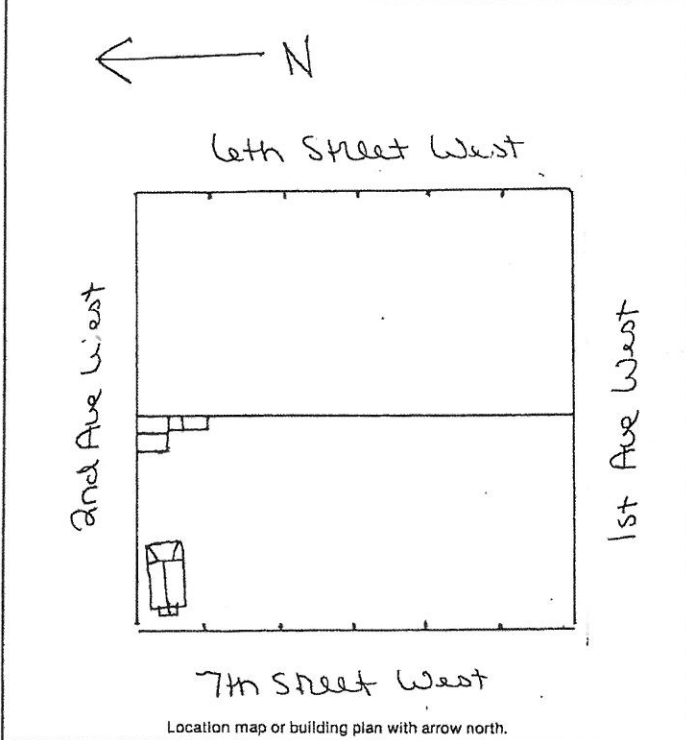
Roll # A4 Frame # 23

This small, one-story, wood-frame rectangular residence has a gable roof, a gable roof enclosed 1/3 front porch, and a hip roof addition to the rear. Other features include an interior brick chimney, exposed rafters, diagonal braces with purlins, 1/1 double-hung windows and fixed square two-light rear windows. The front porch used to be larger, now has 1/1 fixed windows around it and a wood and glass panel front door. A decorative lattice work arbor is on either side of the door. Modern materials include asphalt roofing and masonite siding.

This house is located on the edge of town near the main highway in a block of older homes, some of which are remodeled. This residence has had the front porch made smaller and enclosed, causing some loss of integrity of design, yet still retains basic integrity of design, materials, and craftsmanship.
