# MONTANA HISTORICAL AND ARCHITECTURAL INVENTORY

Address: 202 6th St. West			
Ownership: name: Henry & Dorothy Garman		Roll # 133 Frame # 38	
<input checked="" type="checkbox"/> private <input type="checkbox"/> public	address: 202 6th St. West, Roundup, Mt.

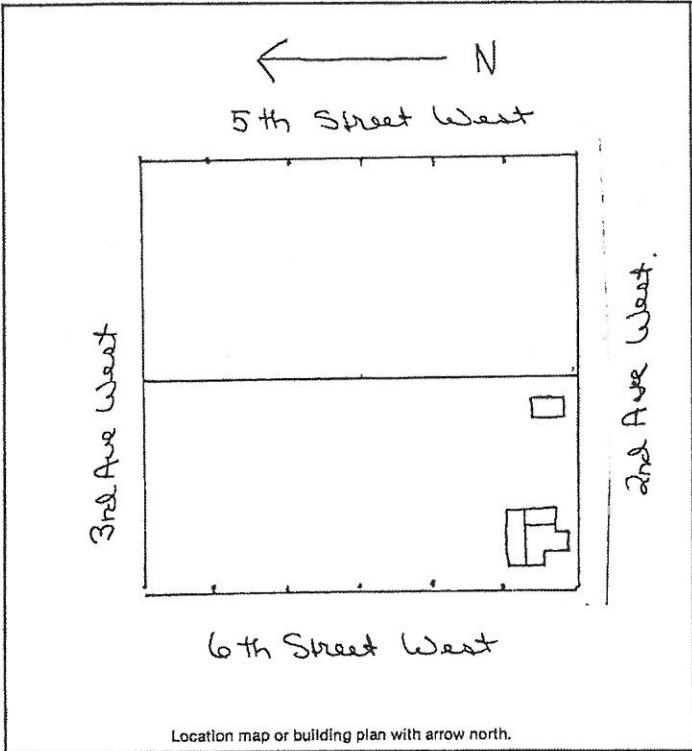
An irregular shaped one-story, wood-frame residence with intersecting gables, adjoining garage, and concrete foundation. Roof has interlocking, T-shaped composition shingle/<sup>roof</sup> and eaves with fascia. Siding is horizontal asonite. Windows and doors are wood frame with wood surround trim, fixed, casement & sliding. Breezeway with corrugated plastic cover joins residence to garage. Small metal shed with pitched roof is located at rear of property.

This residence is located in a block of small older residences. Extensive remodeling, including addition to the building, & use of masonite siding has caused a noticeable loss of integrity.
