MONTANA HISTORICAL AND ARCHITECTURAL INVENTORY

Legal Description: Block 6, Lot 5, Park Steen Addition	
Address: 205 Sixth Street West	
Ownership: name: Mardella A. Green	Roll # A4 Frame # 27
<input checked="" type="checkbox"/> private <input type="checkbox"/> public address: 205 Sixth Street West, Roundup, Mt.

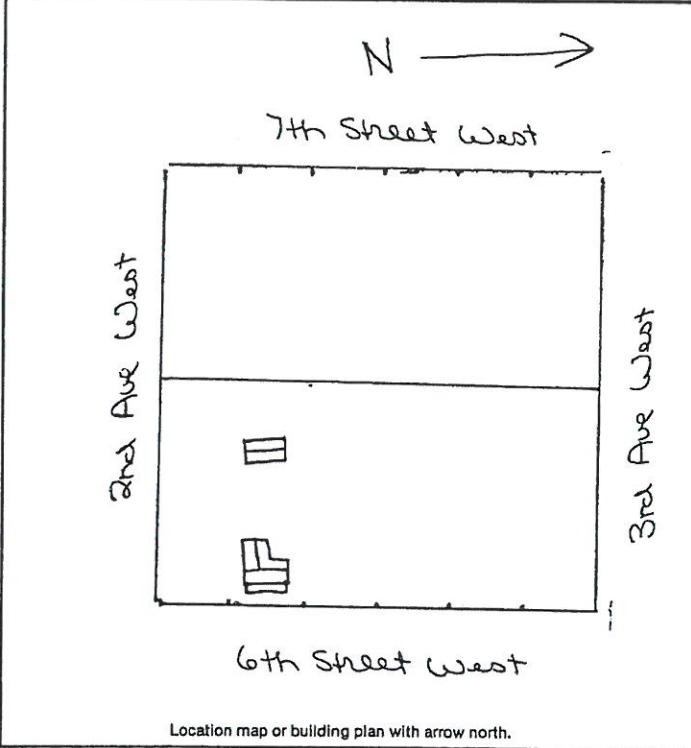
This small L-shaped one-story, wood-frame residence has an intersecting gable roof, and shed roof enclosed front porch. Other features include interior brick chimney, enclosed eaves, 1/1 double-hung windows and 1/1 fixed windows on the front porch, overlap wood siding, with corner boards and a cement foundation. The front door is wood panel with a single light, both front and side entrys have cement stoop and steps. Modern material. used is asphalt roofing.

There is a rectangular wood-frame gable roof garage to the rear with wood roof shingles, wood board siding with corner boards, casement hung garage doors and no foundation.

An interesting feature of this building is that it was originally two small shacks moved in and put together to make a single small residence.

This small house is located in a quiet workingclass neighborhood of mostly moved in, remodeled homes. This house except for the asphalt roofing, has retained integrity of design, materials and craftsmanship. It is an excellent example of a representative small workingclass residence.
