# MONTANA HISTORICAL AND ARCHITECTURAL INVENTORY

Legal Description: Block 6, Lot 8, Steen Addition

Address: 206 7th Street West

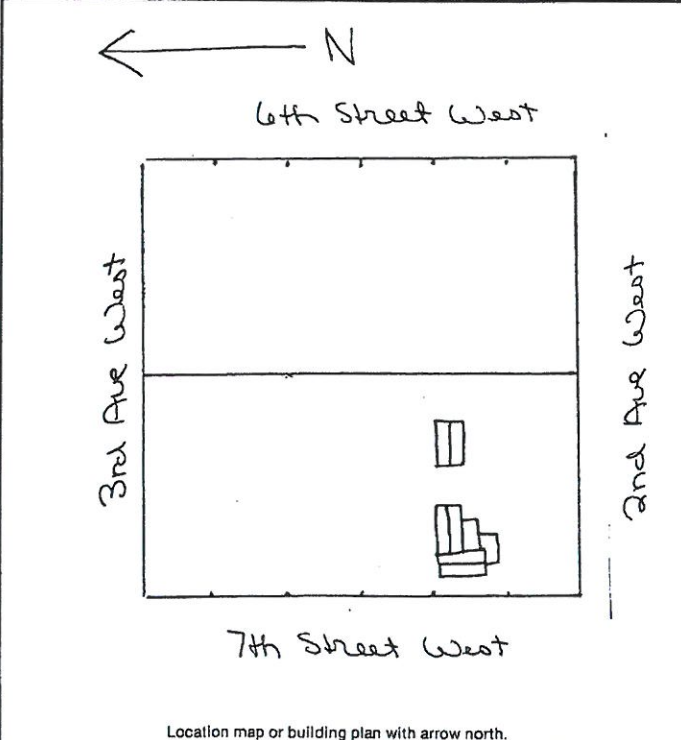
Roll # A4 Frame # 30

This one-story, wood-frame square residence has intersecting gable roofs and a shed roof addition. Other features include a tall interior brick chimney and 2/2 double-hung windows in wood surround, modern materials include two large fixed plateglass windows, one with four-light side lights, modern front door with three lights, asphalt roof shingles and aluminum siding, and a two-step cement stoop with square wood corner posts. There is an attached corrugated metal carport on a cement slab. The house has a cement foundation.

There is a large rectangular corrugated metal garage with gable roof, corrugated metal roofing and siding, metal corner boards, 1/1 horizontal aluminum slide windows, a large rising metal garage door and a cement slab foundation.

This remodeled residence is in a quiet neighborhood of some remodeled houses on the edge of town across from a large horse pasture. The various additions and use of modern materials have caused loss of integrity of design and materials.
