MONTANA HISTORICAL AND ARCHITECTURAL INVENTORY

Legal Description: Block 1, Lot 2, Nelson Addition

Address: 206 First Avenue West

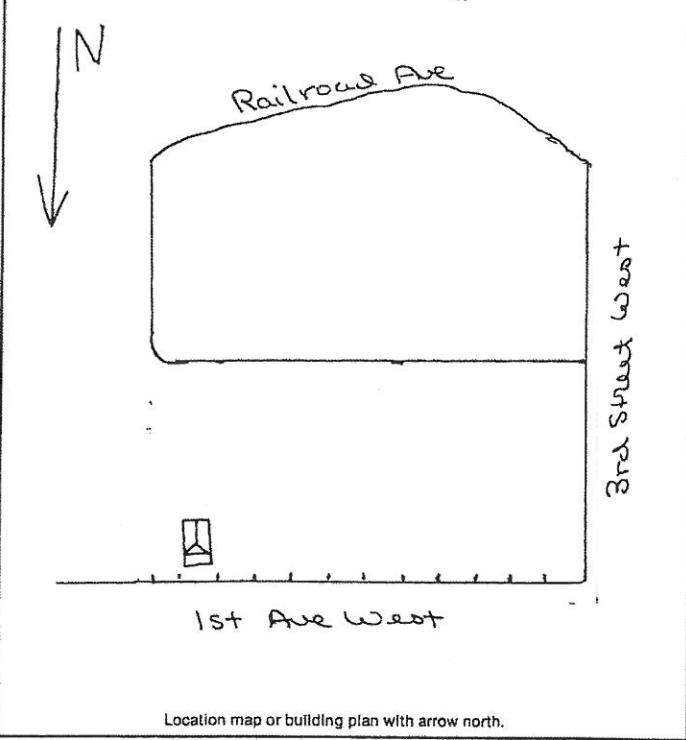
Roll # 32 Frame # 16

A small one-story, gable roof, rectangular wood-frame residence with intersecting gable roofs; aluminum siding, and a concrete foundation. Front gable runs laterally; back gable abuts front gable and extends toward back of property, and has shed roof extension to east side of building. Front porch has shed roof with eaves and visible rafters and extends the front width of the residence. Porch roof has gable dormer with fascia and is supported by square tapered posts on porch apron. Most of the windows are wood frame, double hung 1/1. An aluminum siding window is located on the side. Roof is composition shingle. Front door is wood with panels and lights with wood frame. Side windows are small fixed and casement. Rear side door is wood frame with panels and lights. Building has interior brick chimney of mortar over brick.

This residence is located in a block of other small residences in a working class neighborhood along a major highway. Structure has had several additions and has lost integrity with addition of aluminum siding and aluminum windows.
