MONTANA HISTORICAL AND ARCHITECTURAL INVENTORY

Legal Description: Block 1, Lots 11 & 12, Nelson's Second Addition

Address: 207 1st Ave. West

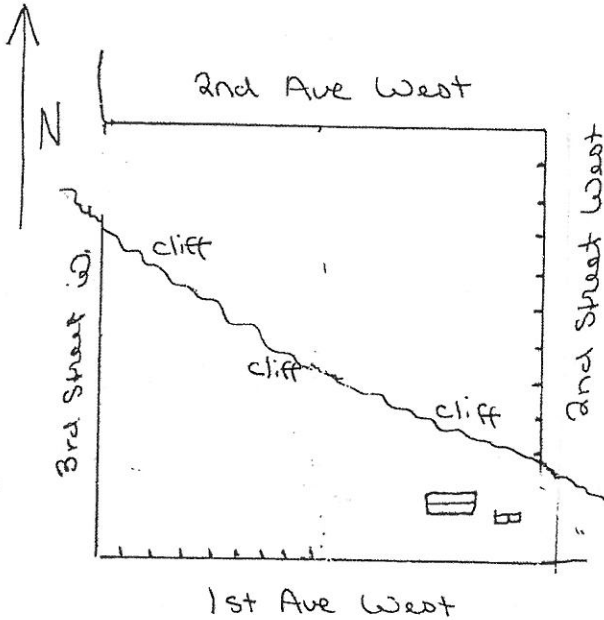
Roll # A3 Frame # 8

This small rectangular, one-story, wood-frame residence has a cement foundation, intersecting gable roofs and a shed roof enclosed rear porch. Other features include 1/1 double-hung windows, asphalt roofing, masonite siding and a narrow square interior stove pipe.

A partially dismantled older residence with a cement foundation, a gable roof covered in old wood planks and metal plates is located at the side of the property. This is a neutral structure.

This small house is on a busy thoroughfare near the commercial district. It has no features to associate it by materials or craftsmanship to an historic period. Modern materials and lack of upkeep have caused loss of integrity of materials and craftsmanship. The addition of a shed-porch has caused loss of design integrity.
