MONTANA HISTORICAL AND ARCHITECTURAL INVENTORY

Legal Description: Block 6, Lot 9, Steen Addition

Address: 210 7th St. West

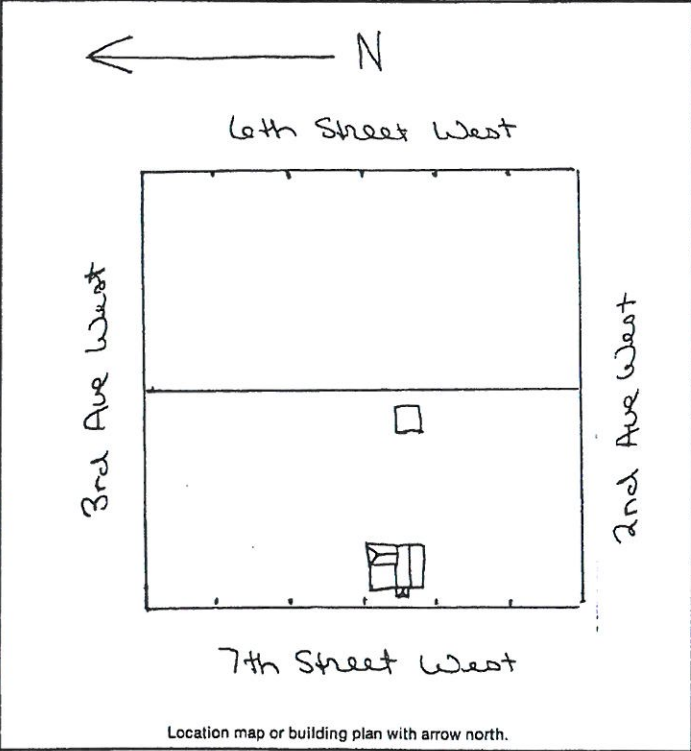
Roll # A4 Frame # 31

This one-story, wood frame residence has a gable roof, a hip roof to the rear at right angles, and a flat roof garage-room with a rounded parapet and false viga ends. Other features include an interior brick chimney, exposed rafters, extended eaves, stucco siding, 6-light rectangular fixed windows in wood surround. Added features include a sealed horizontal wood area where the garage doors were, asphalt roofing, round metal stove pipe, 1/1 sliding wood windows in wood surround, and an aluminum storm door. There is a cement foundation.

The house is surrounded at the base by small sandstone flat rocks with a cement layer on top. There is a short stone fence of this coarsed rough-cut dry bonded sandstone with a tiny picket fence on top. There is a cement slab walkway along the south.

There is a square, tall, one-story, wood-frame, gableroofted storage shed with exposed rafters and purlins, corrugated metal roofing, horizontal wood siding with corner boards, 1/1 double hung windows in wooden surround.

This is a quiet neighborhood on the edge of town right across the street from a large horse pasture. The homes are a real odd collection of buildings. This home has a gable roof and a stucco parapet with logs sticking out of it in an adobe fort garage.
