MONTANA HISTORICAL AND ARCHITECTURAL INVENTORY

Legal Description: <u>Block 3, Lot N1/2S, S1/2 6, Park Addition</u>	
Address: <u>22 6th Street West</u>	
Ownership: name <u>Allen Bublich</u>	Roll # <u>B3</u> Frame # <u>8</u>
<input checked="" type="checkbox"/> private <input type="checkbox"/> public address: <u>12 6th Street West, Roundup, MT</u>

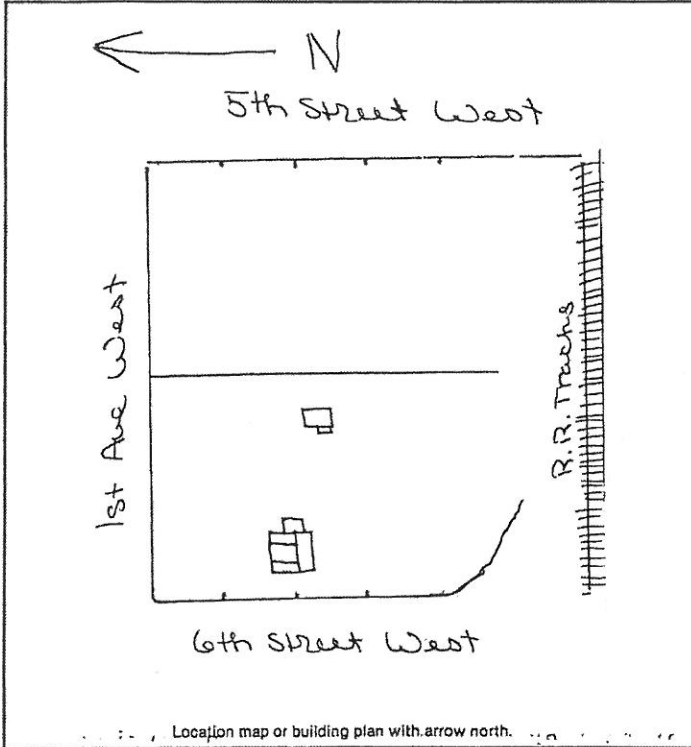
A one-story rectangular residence with intersecting gables, a front hip roof porch and rear hip roof extension and cinder block foundation. Building has composition shingle roof, two interior brick chimneys and clapboard siding with end boards. Windows and doors are wood-frame with wood-surround trim. Windows are double-hung 1/1. Front door to porch is wood with panels and lights. Front porch is enclosed with clapboard siding.

Significant architecture features are front gable end over the front porch, small window-in-front gable end, and gently sloping front porch roof.

Two adjoining deteriorating wood-frame sheds are located at the rear of the property. One has gradually sloping gable roof, vertical plank siding and board and composition sheet roof. The other has a shed roof, horizontal board siding, and wood shingles.

This is a contributing structure.
