MONTANA HISTORICAL AND ARCHITECTURAL INVENTORY

Legal Description: Block 6, Lot 11, Steen Addition
 Address: 220 7th St. West
 Ownership: name: Virgil & Mabel Cross
 private public address: 220 7th St. West, Roundup, Montana

Historic Name: _____
 Common Name: _____
 Date of Construction: 1917 estimated documented
 Architect: Remodeled 1953 (estimated)
 Builder: _____
 Original Owner: Della E. Cain
 Original Use: Residence
 Present Use: Residence

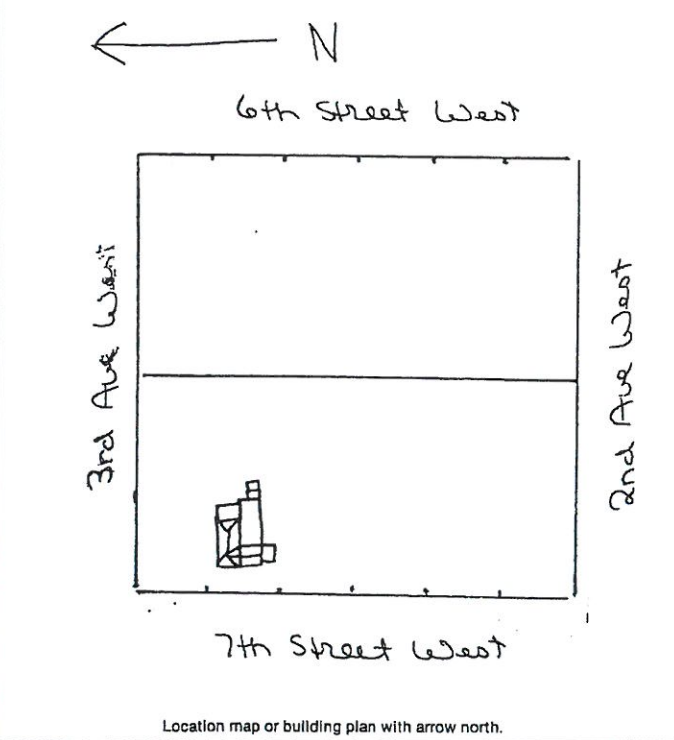
Roll # A4 Frame # 33

This one-story irregular shaped house has two hip roofs at right angles, a large flat roof addition toward the rear and a covered patio. Other features include two interior chimneys (one cement block, one a tall metal stove pipe), asphalt roof shingles, assorted windows 1/1 double-hung in wood surround, large rectangular fixed with 1/1 small sliding wood windows underneath them, 1/1 sliding aluminum frame. Also a wood door with rectangular lights, steel siding, metal slate awnings. Attached to the house is a garage with large metal rising doors, a corrugated metal roof car-port with a cement slab foundation. The house is on a raised cement foundation with front cement stoop. The patio is screened, has a flat metal roof and metal supports.

To the rear is an attached storage shed of corrugated metal.

This house, part moved in around 1920, part added to then and later, is located in a quiet neighborhood with other moved in remodeled homes, and across from a large horse pasture. Extensive additions have entirely hidden the original structure thus causing loss of integrity of design and materials.
