MONTANA HISTORICAL AND ARCHITECTURAL INVENTORY

Legal Description: Block 1, Lots 20 - 22, Nelson Second Addition	
Address: 221 1st Ave. West	
Ownership: name: Leroy Newton	
<input checked="" type="checkbox"/> private <input type="checkbox"/> public address: 223 1st Ave. West, Roundup, Mt.	Roll # A3 Frame # 10

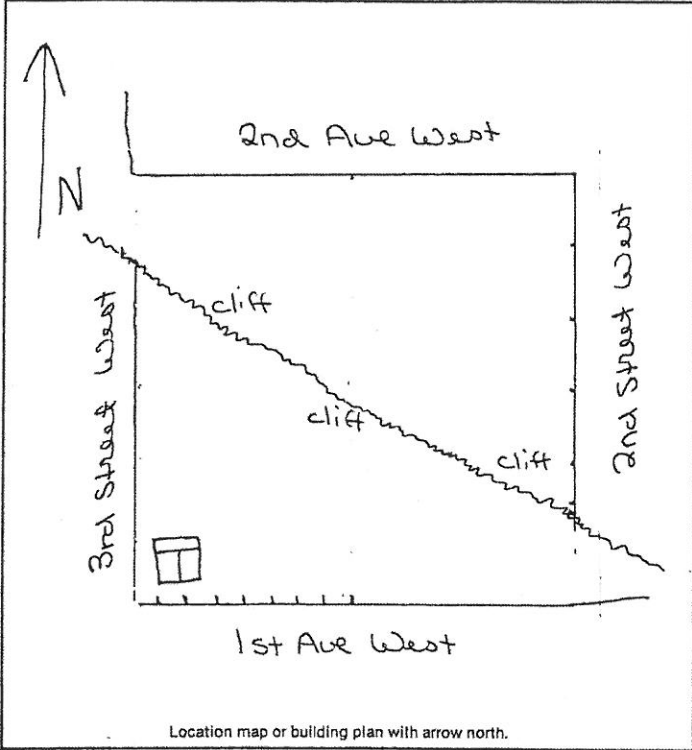
This 1¼-story square, wood-frame residence has two intersecting gable roofs. Other features include blue asphalt shingles, gray masonite siding, and a raised concrete foundation with fixed windows. Also included are a small 1/1 double-hung window in the gable, 2 oversized rectangular windows with 4-light side windows, metal slate curved awnings over old windows and a huge concrete stoop with steps and iron bar railing.

This old house is on a mixed commercial/residential busy thoroughfare. It was moved into the area after 1950 and has been remodeled since then, which has caused a loss of integrity of location and materials.
