MONTANA HISTORICAL AND ARCHITECTURAL INVENTORY

Legal Description: Block 6, Lot 12, Steen Addition
 Address: 224 Seventh Street West
 Ownership: name: Thomas D. Dunn
 private public address: 210 Seventh Street West, Roundup, Mt.

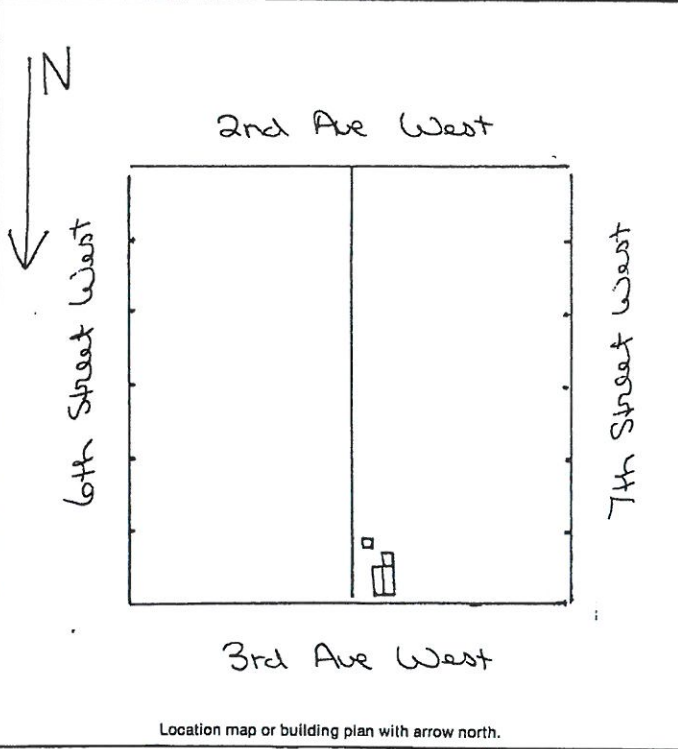
Roll # A4 Frame # 34

This small rectangular wood-frame one-story residence has a gable roof and a shed roof rear addition. Other features include wood roof shingles, enclosed eaves, beveled edge wood siding with corner boards, wood under eaves trim board, narrow 1/1 double-hung windows in wood surround, wood foundation, a wood panel in wood surround back door, a front wood and glass panel door. There are modern cement steps in back and a slab step in front, and 1/1 fixed window in wood surround.

There was no back addition on the building originally, and a side porch was probably enclosed at sometime.

To the back is an old shed roof outhouse with board siding, wood paneled door and no foundation.

This small house at the back of the property is located in a block of extensively remodeled older homes. This house faces the side street. Probably a side porch was enclosed, yet this house still retains integrity of location, materials, basic design and craftsmanship.
