# MONTANA HISTORICAL AND ARCHITECTURAL INVENTORY

Address: 23 3rd St. West

Date of Construction: 1910 Remodeled 1975  estimated  documented

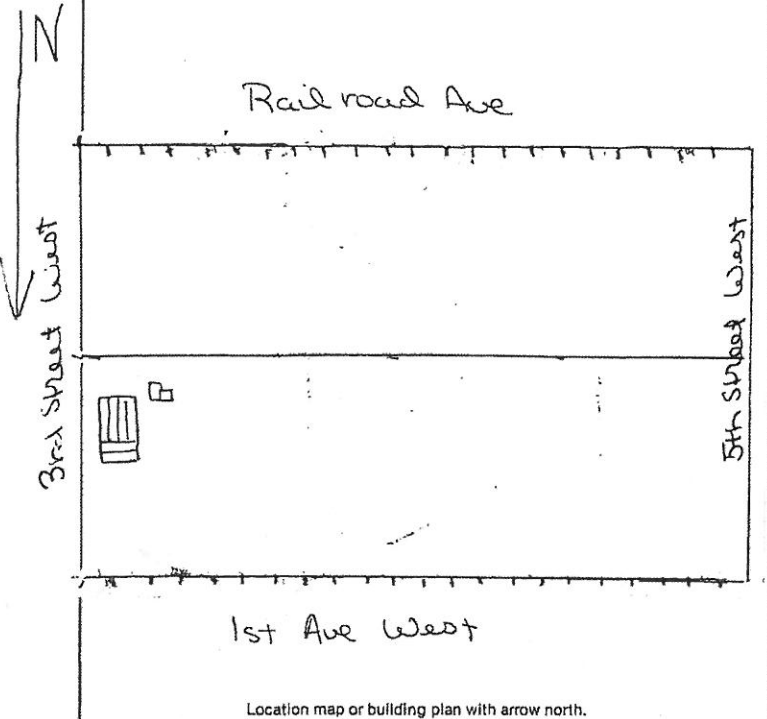
Roll # A3 Frame # 37

This one-story, wood-frame rectangular residence has intersecting gable roofs in the middle of the house causing a peak, with side shed additions and a front shed roof addition. Other features include: stone block exterior chimney, asphalt shingles, 1/1 fixed, large rectangular windows, wide aluminum siding and a cement foundation. An architecturally significant feature is the central peaked roof, that showed some of the old roofline before remodeling.

There is a garage of beveled edge wood siding with gable roof, wood roof shingles, a corrugated metal shed roof attachment, and a 6-light window in the door to the garage.

This old house is located on a commercial thoroughfare of mixed old and new structures. It has been remodeled so often that only the strange central peaked roof remains from its origins. Modern materials completely cover the original fabric of the house causing loss of materials integrity. The many additions over the years have caused loss of integrity of design.
