MONTANA HISTORICAL AND ARCHITECTURAL INVENTORY

Address: 303 Sixth Street West

Date of Construction: 1910 ^{moved 1936} remodeled 1945 estimated documented

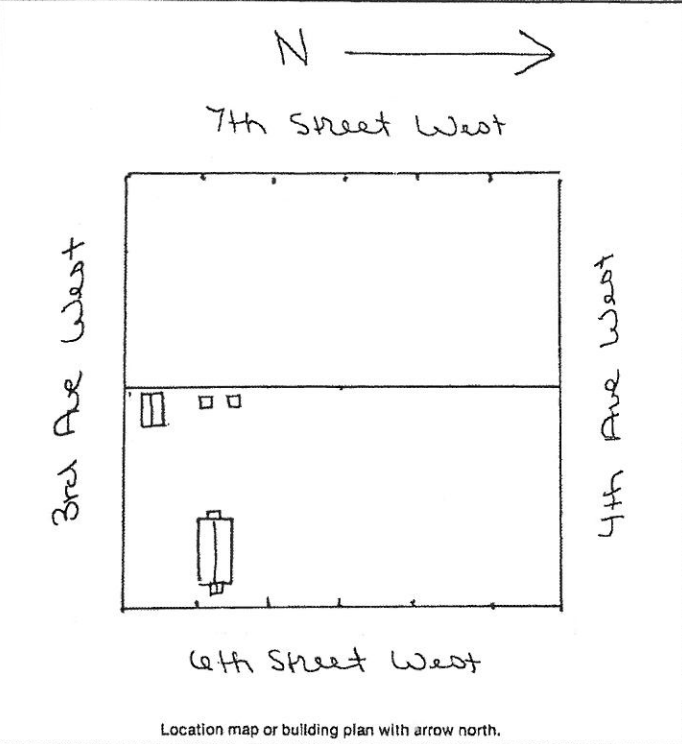
Legal Description: Block 7 lots 5 and 6 Steen addition	Roll # A5 Frame # 9

This rectangular one story wood frame residence has a gable roof, and over the front and rear doors is a gabled hood with wood shingles, collar beam and diagonal braces. Other features include 2/2 double hung windows, wide water table board, enclosed eaves with trim board, and a wooden front stoop.

Modern materials include asphalt roofing, cement block chimney, vertical wood paneling with corner boards, wide horizontal gable paneling, cement foundation (added 1964), and 1/1 slide wood windows in the rear. There is a wrought iron rail to the front stoop.

This house is located in a quiet neighborhood of older homes, some re-modeled, many moved into the area. This house has lost some integrity with a bathroom added in 1940, and a rear addition in 1945. New siding was put on in 1964. Despite the enlargement of this house, and new siding, this house retains integrity of design and craftsmanship.
