# MONTANA HISTORICAL AND ARCHITECTURAL INVENTORY

Address: 304 Seventh Street West

Date of Construction: 1903 Moved 1936  estimated  documented

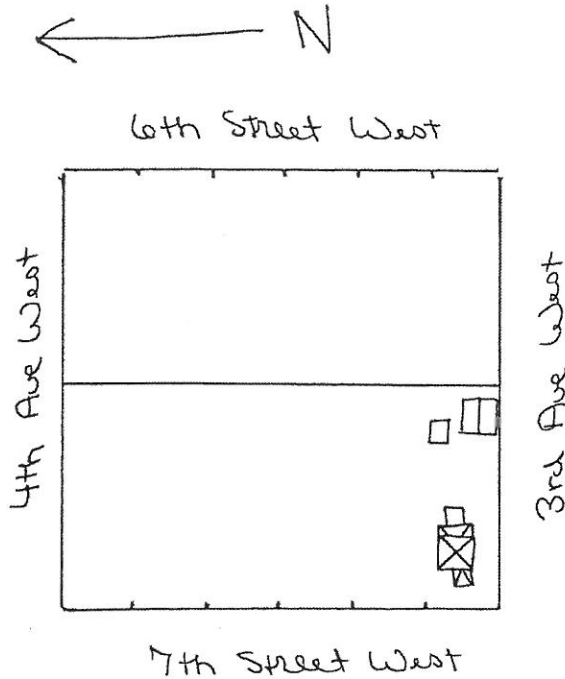
Roll # A5 Frame # 10

This rectangular one-story wood frame residence has a pyramid style hip roof with central chimney, hip roof enclosed front porch and a hip roof full back addition. Other features include enclosed eaves, small 1/1 double-hung windows in the front porch, larger 1/1 double-hung and slide windows in wood surround, overlap wood siding with corner boards and a cement foundation. Modern materials are asphalt shingles on the roof and a corrugated fiberglass patio cover to the rear. Out-buildings include 1. A tall one-story wood frame garage with wood panel siding, casement hung plywood garage doors, aluminum 1/1 fixed and slide windows on a concrete slab 2. an uneven gable roof shed with siding and roofing of raw wood, horizontal overlap, wood shingles, asphalt and corrugated metal.

This house was moved from the mine site when it closed and relocated to its present place.

This mine house is located in a neighborhood of predominantly moved-in and re-modeled residences at the edge of town across from a large horse pasture. The house has lost integrity of location, but has good integrity of design, materials, and craftsmanship.
