MONTANA HISTORICAL AND ARCHITECTURAL INVENTORY

Legal Description: Block 7, Lot 8 & 10' of 9, Park-Steen Addition
 Address: 308 7th St West
 Ownership: name: Dora J. Doughton & Timothy Paul Anderson
 private public address: 308 7th St. West, Roundup, Mt.

Historic Name: _____
 Common Name: _____
 Date of Construction: 1920 estimated documented
 Architect: _____
 Builder: _____
 Original Owner: Michael McGonnigal
 Original Use: residence
 Present Use: residence

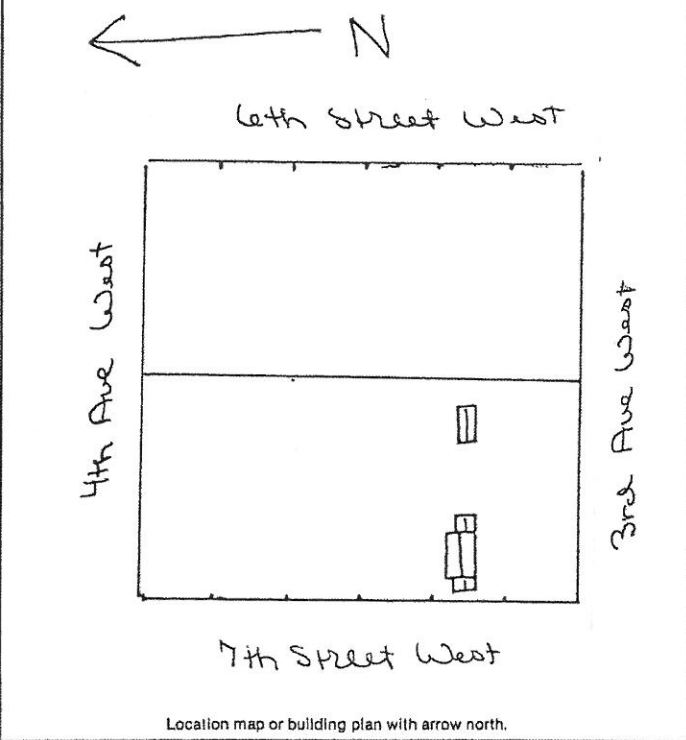
Roll # A5 Frame # 11

This one-story rectangular wood-frame residence has three different pitches of gable roof and four different style windows. Originally it was a two room house with central brick chimney. It has a large gable front addition and a small gabled rear addition. In the front addition is a combination fixed, 16-light rectangular window in wooden surround. On the north front are two vertical, rectangular fixed windows. To the south is an 8-light combination window. On the main building are 3/1 double-hung, 1/1 double-hung, 1/1 fixed windows all in wooden surround. The rear porch area has small 1/1 double-hung windows. The front and main house is paneled in vertical wood paneling, and the back is asphalt siding. There are asphalt shingles on the roof, a cement foundation, a wood and glass panel front door with aluminum storm door.

There is a long, low, gentle pitched gable roof storage building with 3/1 horizontal slide window in wood surround and wood board door, no visible foundation, asphalt (brick print) siding and part- asphalt, part wood shingle roof.

This house, moved into this area from the mines before 1936, is located in a neighborhood mostly of other small houses, many also moved in. This house has been remodeled many times leaving only the original enclosed eaves of the first house. Modern materials cover the original structure causing loss of integrity of materials. The large front addition causes loss of integrity of design.
