MONTANA HISTORICAL AND ARCHITECTURAL INVENTORY

Address: 309 4th St. West

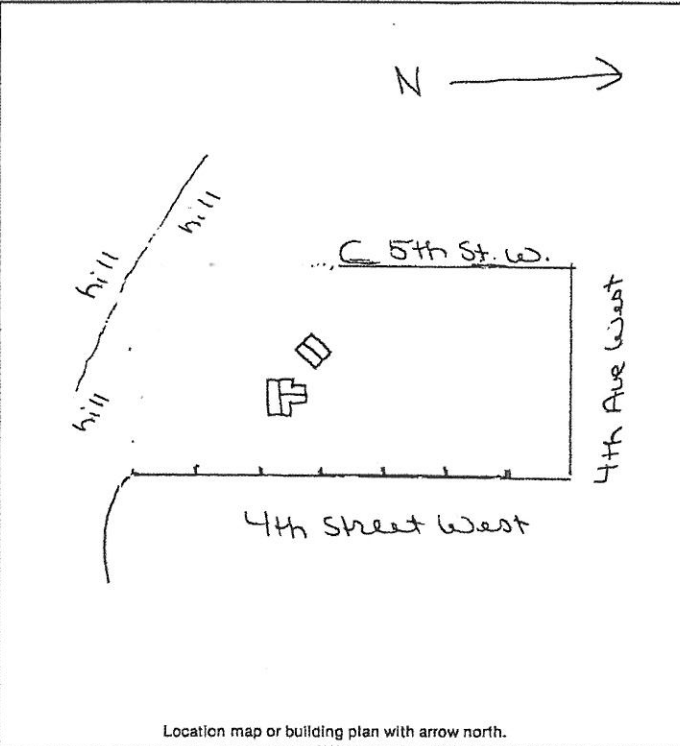
Roll # A12 Frame # 8

A one story, T-shape residence with intersecting gable roof, masonite siding, & concrete cement block foundation. This building consists of several sections, one with gable roof, the other with shed roof. Roof has interior brick chimney, interlocking T-shape composition shingles, & eaves with fascia. Windows are wood frame, double hung 1/1 and 6 pane casement. Front door is wood frame, with small, square panels and 6 pane light. Front door has concrete stoop and iron railing. Original structure is alleged to be a railroad car. A large, square, wood frame two car garage with gable roof, eaves & fascia, horizontal lap seam siding, two horizontal hinged, upward sliding garage doors, with panels, lights, and concrete foundation, located at rear of property. It was built in 1971. This is a neutral structure.

This residence is located in a half-block of other older small & large residences. It has lost integrity of design & materials, with the several additions, and addition of masonite siding. The addition of the large garage in 1971 has caused some loss of integrity of setting.
