MONTANA HISTORICAL AND ARCHITECTURAL INVENTORY

Legal Description: Block 12, Lots 7 - 9, Steen Addition

Address: 310 6th St. West

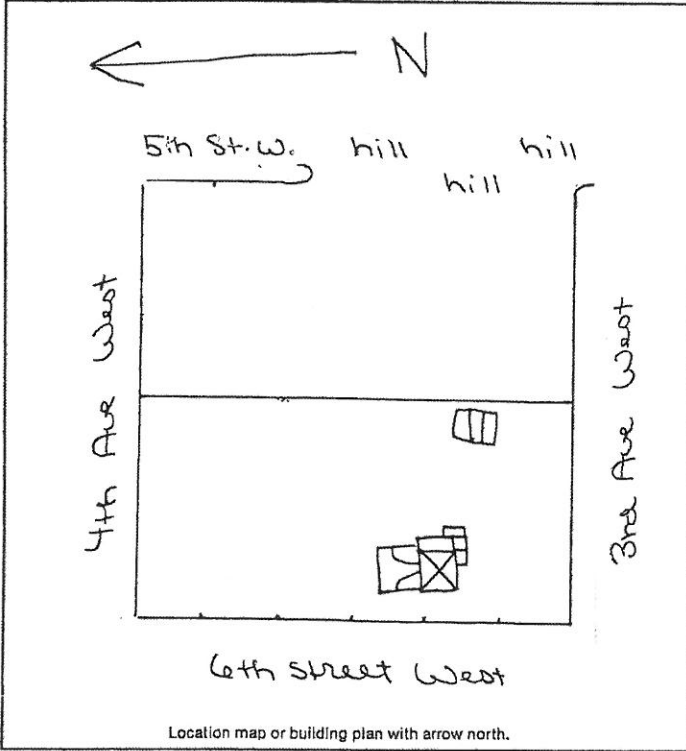
Roll # A5 Frame # 2

This large one-story wood-frame house has an original pyramid style hip-roof with added combination gable and wood roof shingles, central brick chimney, 1/1 double-hung windows, and a cement foundation. Added features include an asphalt roof to the north, two large square wood fixed south windows, 1/1 fixed aluminum windows, steel siding, aluminum storm doors. There are two wooden steps up to the gabled front entry addition, and aluminum awning over the southern square windows.

To the rear is a wood-frame double garage with gable roof, and a batten wood siding, and corrugated metal roof. Attached to it is a shed roof, horizontal wood siding with corner boards, asphalt roofing storage shed. The garage is on a cement slab and was built about 1960.

This mine house, moved into the area in approximately 1936, is located in a neighborhood of other moved in, remodeled mine houses. This house has been remodeled so much only the pyramid roofline is recognizable. No effort has been made to fit new and old rooflines together. Remodeling has caused loss of integrity of design. Steel siding and aluminum windows have caused a loss of integrity of materials.
