MONTANA HISTORICAL AND ARCHITECTURAL INVENTORY

Address: 311 6th Street West

Original Owner: John Tomis

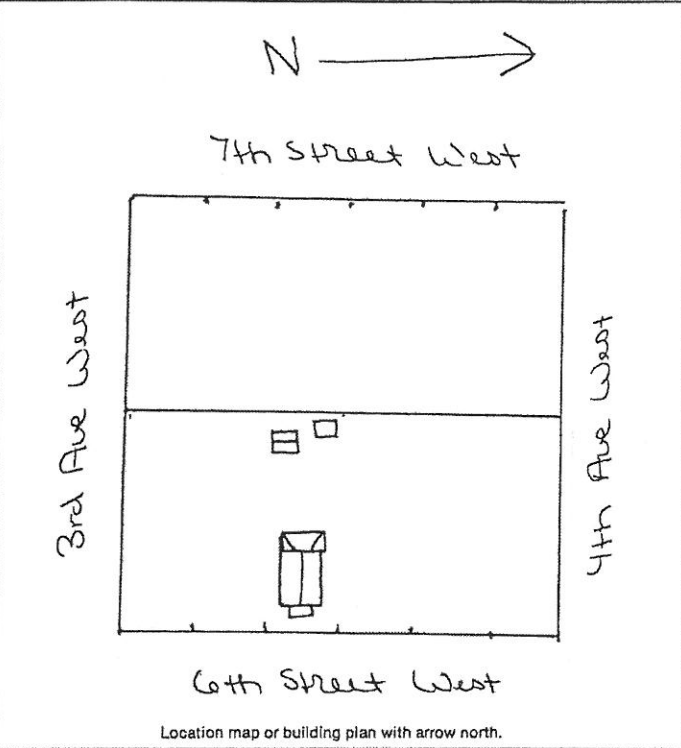
Roll # A5 Frame # 8

This rectangular wood frame, one-story residence has a gable roof and a hip roof back porch and 1/1 narrow double-hung windows. That is all that's left of the original house. A cement block foundation was added in the 50's. There are asphalt shingles, one brick chimney, a large stove pipe chimney with cap and filter, and a turning air vent on the roof. Other features are aluminum horizontal siding, with vertical paneling in the gable, a four-step cement stoop with wrought iron rails, a small gabled stoop overhang in wood with wood paneling, a three-light and wood panel front door, covered by a wood and screen storm door.

Outbuildings include: 1. A tall rectangular shed roof building - wood frame and siding with asphalt sheeting covering all and a wood board door. 2. A wood frame rectangular gable roof garage with asphalt siding, roofing, corner boards, fixed one-light window, wood panel and bubble glass door in wood surround. No foundation for either building.

This remodeled house is located in a neighborhood of remodeled mine houses, moved in to the area. This home has been extensively enlarged and remodeled, including the eaves. Although the original windows remain remodeling has caused loss of integrity of design and materials, and loss of historic sense.
