MONTANA HISTORICAL AND ARCHITECTURAL INVENTORY

Address: 315 Sixth Street West

Common Name: Johnny Simanich's House

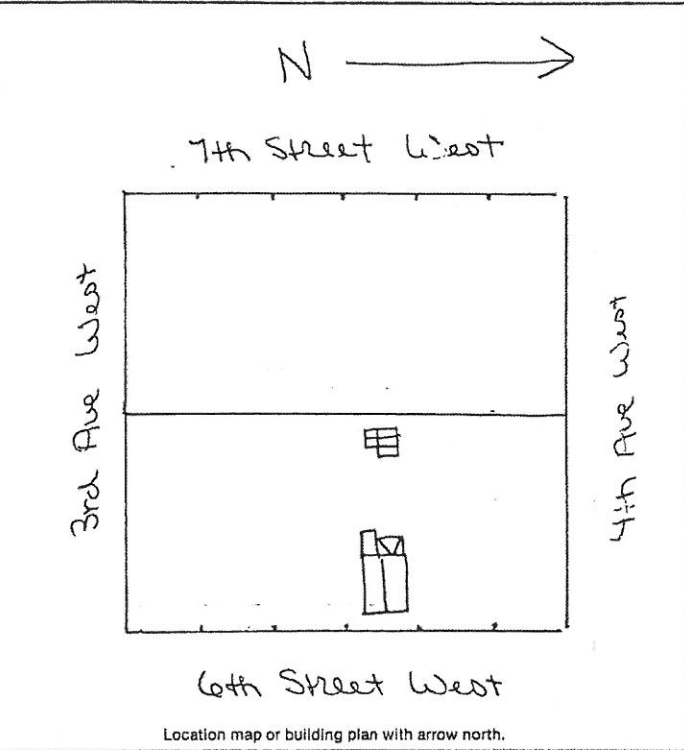
Roll # A5 Frame # 7

This one and one-half story rectangular building is made of logs, wood frame and cement blocks. It has a gable roof with two interior chimneys (one with a central pipe extending from it), wood shingles on the roof, eaves with exposed rafters and 1/1 double-hung windows, and 1/1 fixed windows, 2/2 double-hung windows, 4/4 double-hung and a small 1/1 double-hung window in the upper gable.

This house was originally a one-room log cabin, then a second cement block room was added with the upstairs, then the back was framed in and shed and hip roof additions put on.

To the rear is a second story wood board door over the roof of the shed addition. The siding is stucco with one log corner board still exposed, wood shingles over the rear additions and asphalt roofing in the rear. There is a large extended cement sill under the front pair of 1/1 double-hung windows.

To the rear is a log "squatters" cabin, originally square with gable roof, hewed logs with cement chinking, boarded up windows and doors. Added to this is a board and batten gable roof addition. Asphalt roofing over all, no foundation. Added further was a square tall, gable roof wood sided with corner boards added space with fixed and 1/1 double-hung windows.

Both these structures show the "add-on" nature of the local architecture. This is a contributing structure.

This unusual house is located in a block of predominantly moved-in and remodeled houses. This house was built here and added to as needed. Despite a need for upkeep, this house retains integrity of design and materials.
