MONTANA HISTORICAL AND ARCHITECTURAL INVENTORY

Address: 317 Sixth Street West

Date of Construction: 1900, Moved 1936 estimated documented

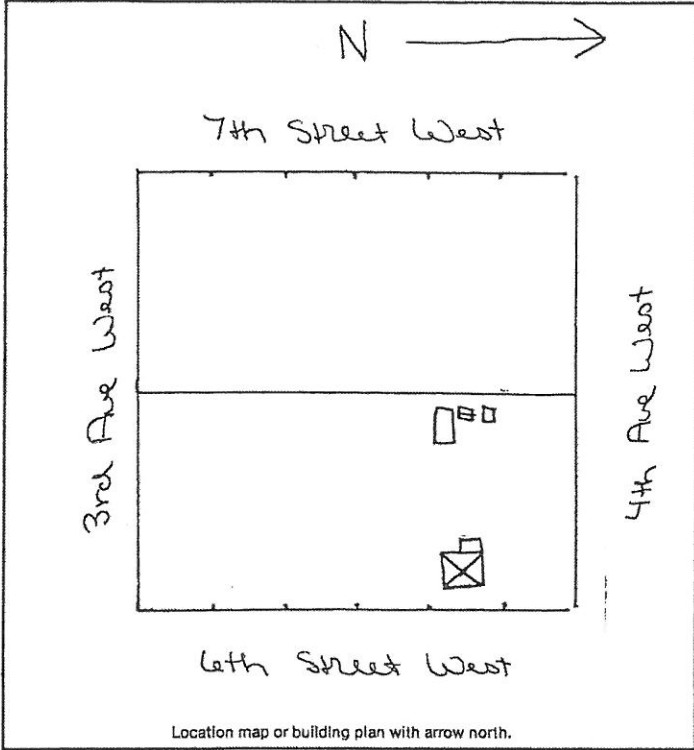
Roll # A5 Frame # 6

This small square wood frame residence has a pyramid roof, central brick chimney, enclosed eaves, 2/2 double-hung windows, and exposed area above the front door where the porch was attached before moving. There is a wood panel door with rectangular transom. More modern materials include a shed roof addition with wood board and tarpaper siding, asphalt roof shingles, and wood and glass paneled door. The house has asphalt shingles and is on a cement foundation. Outbuildings include:

1. A shed roof board and batten siding, wood board roof old stable with dutch doors,
2. A gable roof outhouse with beveled edge siding, cornerboards, wood roof shingles, wood louvered covered window,
3. A board and batten sided garage with casement hung doors, flat roof, and no foundation.

This old mine house is located in a quiet workingclass neighborhood of older homes, moved in and remodeled. This unremodeled house has excellent integrity of craftsmanship, design, and materials. It is a good example of a representative mine house.
