MONTANA HISTORICAL AND ARCHITECTURAL INVENTORY

Address: 323 Sixth Street West

Date of Construction: 1924 estimated documented

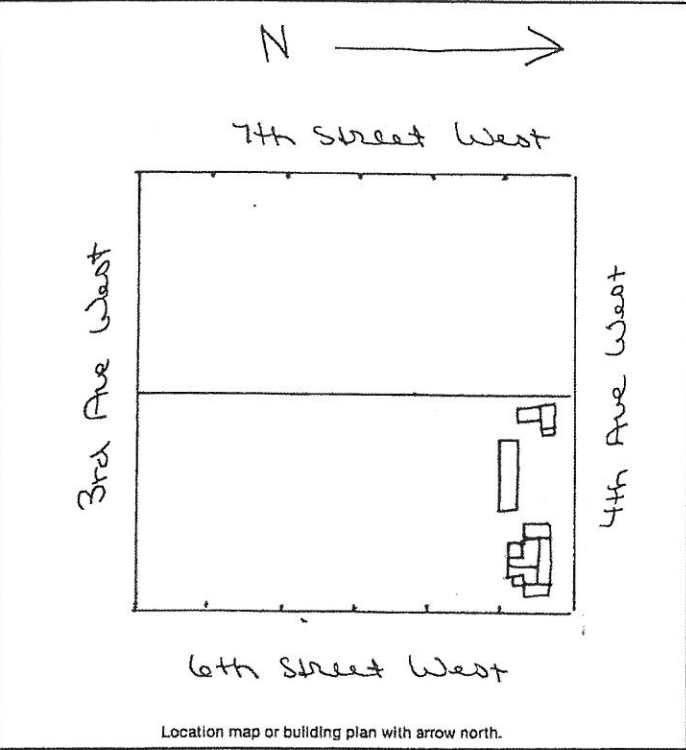
Roll # A5 Frame # 5

This is a rectangular one story wood frame building with an intersecting gable roof, a full enclosed shed roof front porch and a shed roof addition to the rear. Other features include extended eaves, wood overlap siding in the gable with plain wood trim at the roof line, narrow 1/1 double hung windows in the enclosed porch, 6/6 double hung windows on the southern section, a wood and glass panel front door and a sandstone block foundation. Modern features include a shed roof addition to the south side, a covered fiberglass patio on a cement slab, an exterior cement block chimney, asphalt roofing, vertical wood paneling, a fixed rectangular wood surround north window, 3 light sliding north window in wood frame, and an aluminum storm door.

There is an L-shaped three shed roofed shed of wood board horizontal asphalt roofing, no foundation and wood board door in wood surround.

This is a contributing structure.

This house is located in a quiet working class neighborhood with many houses moved in and remodeled. This house was originally two houses moved in and fit together. There is loss of integrity of location (the two houses moved together) and materials (the wood siding) yet the integrity of design and craftsmanship is basically retained.
