MONTANA HISTORICAL AND ARCHITECTURAL INVENTORY

Address: 323 Third Street West

Original Use: residence

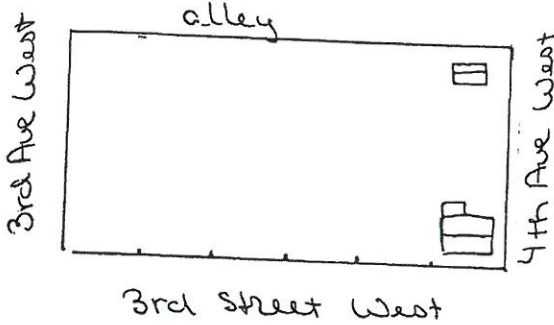
Frame # 27

A one-story ell-shaped wood-frame residence with gabled roof, extending eaves, with fascia, recessed front porch and rear gable roof extension and concrete foundation. Building has corbeled T-shape brick chimney, wood shingles, clapboard siding, and rafters under the eaves. Front porch is open under eave extension with square posts on clapboard railing (apron). Bottom of front porch has lattice work. Front and side of building has large fixed wood frame windows. Most other windows are wood frame, double-hung 1/1 with wood-surround trim and drip board and sill. Front door is wood with diagonal lights, wood frame and wood surround trim.

Cement block garage with gable roof, wood shingles and two upward sliding garage doors with multi-panels and lights is located at rear of property.

This is a contributing structure.

This residence is located in a block of other, older residences of comparable scale. It possesses integrity of setting, design, materials and workmanship, and conveys a clear sense of the property's historical associations even though it was moved to this site.
