MONTANA HISTORICAL AND ARCHITECTURAL INVENTORY

Legal Description: Block 2, Lots 33 - 35, Nelson Addition

Address: 323 Railway

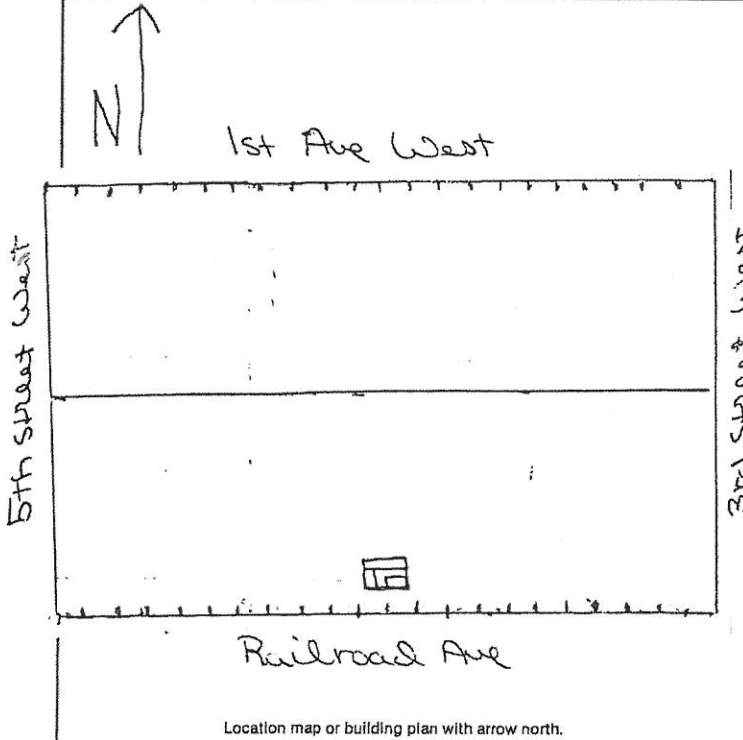
Roll # A4 Frame # 11

This square one-story wood-frame residence has intersecting gable roofs with a shed roof addition. Other features include: part masonite siding, part beveled edged wood, modern aluminum frame slide windows, modern paneled front door with colonial decorative glass side lights, cement foundation, and plywood covering the old porch. It has a central stretcher bond chimney.

There is a cement block gable roof outbuilding with wood siding in the gable area.

This gable roof residence is down by the railroad tracks, with one other house around. All the houses across the street have been torn down and the big trees cut causing loss of integrity of setting. Recent remodeling, modern windows and doors, and the enclosure of the porch has caused loss of integrity of design and materials.
