MONTANA HISTORICAL AND ARCHITECTURAL INVENTORY

Legal Description: Block 7, Lot 11 & 12, Steen Addition
 Address: 324 7th Street West
 Ownership: name: Dudley W. & Borghild Newman; Judith Maxine Whisonant
 private public address: Box 173, Lavina, Mt. 59046

Historic Name: _____
 Common Name: _____
 Date of Construction: 1920 moved in 1936 estimated documented
 Architect: _____
 Builder: _____
 Original Owner: Bess Pettit (at this site)
 Original Use: Residence
 Present Use: Residence
 Research Sources:
 abstract of title city directories
 plat records/maps sewer/water permits
 tax cards obituaries
 building permit biographies
 Sanborn maps — dates: Not mapped 1912 or 1920
 Bibliography:
Interview: Betty Tucker July 21, 1983
Chain of Ownership cards, Clerk and Recorder's Office

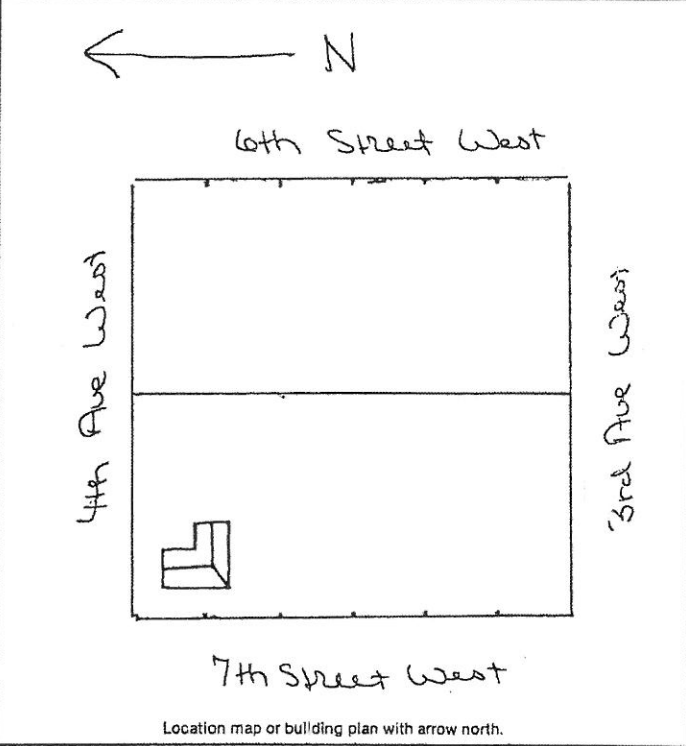
Roll # A5 Frame # 13

This one-story, wood-frame residence has a combination hip and gable roof. Part of the house has eaves, part doesn't, so either two houses were fit together or a major addition was added. Assorted windows include 1/1 double-hung, regular and small size windows, 1/1 horizontal slide windows in wood surround. Around the front door is narrow wood vertical paneling, and the front door is modern wood with three gargoyles. Siding is wide aluminum, roof is asphalt shingles. There is a cement foundation.
 This is a neutral structure.

This old mine house, moved here in approximately 1936, is located in a quiet neighborhood of older remodeled, moved in homes. A horse pasture is across the street. Remodeling and additions have effectively hidden the original house, causing loss of integrity of design. And modern siding and windows have caused loss of integrity of materials.
