MONTANA HISTORICAL AND ARCHITECTURAL INVENTORY

Legal Description: Block 2, Lots 15 & 16, Nelson Addition

Address: 332 1st Ave. West

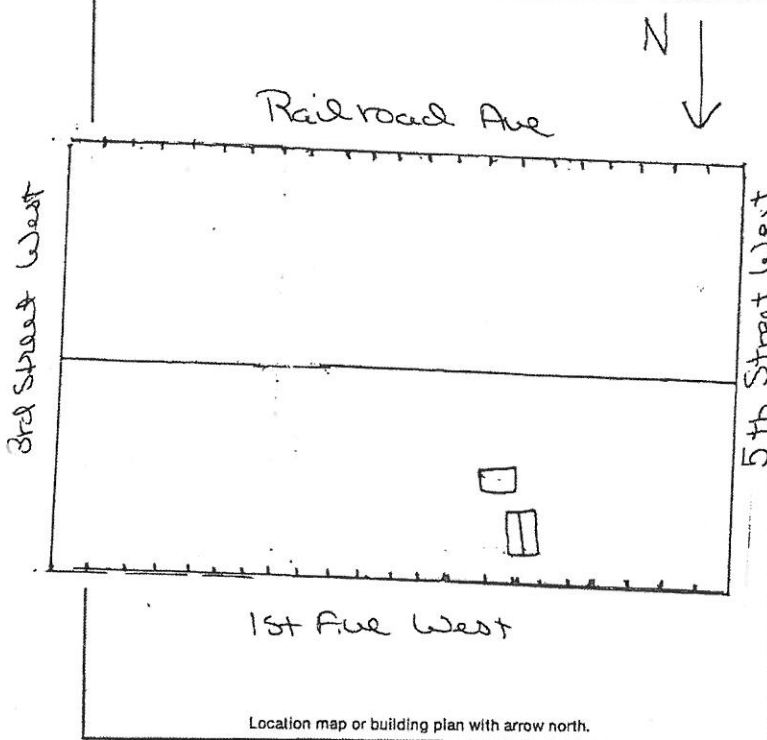
Roll # A4 Frame # 14

This small rectangular, one-story, wood frame residence has a gable roof with extended enclosed eaves and an exterior partially stepped cement block stretcher bond chimney. Other features include: asphalt roofing, horizontal wood siding in the gable area, vertical wood panel siding with corner boards, 1/1 double hung windows, and a wood panel door. The foundation is a concrete slab.

A garage to the rear is one-story wood and corrugated metal with sliding wood doors. It has a rounded asphalt covered roof. The siding is wood overlap. No visible foundation.

This is on a busy commercial thoroughfare of mixed modern commercial and older residential structures. The use of modern vertical wood paneling and other modern materials, and a large exterior chimney addition causes loss of integrity of materials and design on this simple structure.
