# MONTANA HISTORICAL AND ARCHITECTURAL INVENTORY

Address: 4th Avenue West

Date of Construction: 1940's

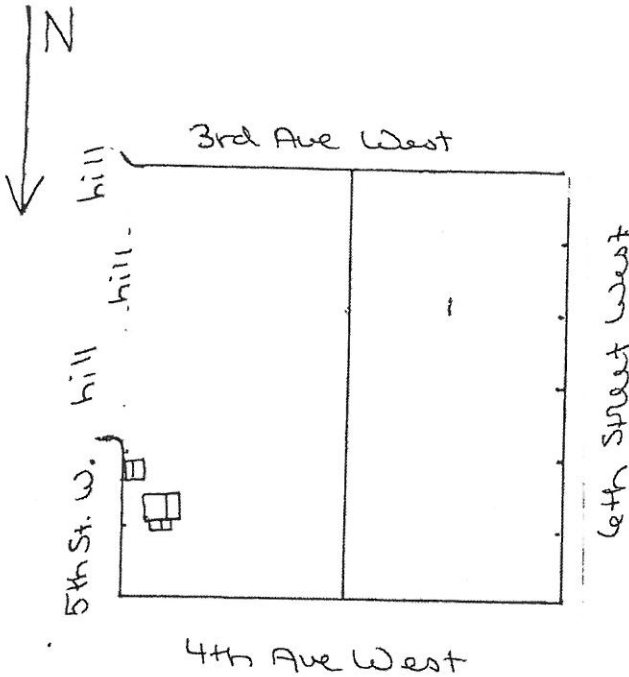
Roll # A4 Frame # 35

This gutted one-story, wood-frame residence has a steeply peaked gable roof with a catslide to the east, a shed addition to the west, and an off-center gable roof addition to the front. Other features include wood roof shingles, brick printed asphalt siding painted turquoise, 1/1 double-hung windows in the rear, boarded up wood door, demolished brick chimney and cement foundation.

There is a gable roof rectangular storage shed with wood shingle siding front, asphalt roofing, wood shingle covered door, west side horizontal overlap wood and partially open siding. No foundation.

This building is being dismantled.

This little house is located on the edge of a cul-de-sac, across from a large garden, a pipe storage yard and shares the lot with a mobile home down the hill. This house is partially dismantled and has lost integrity of materials. Its state of disrepair is intrusive to the area.
