MONTANA HISTORICAL AND ARCHITECTURAL INVENTORY

Legal Description: Block 8, W 1/2 of Lot 7, & W 90' of Lot 8, Steen	
Address: 402 7th Street West	Addition
Ownership: name: Christian Wanner	
<input type="checkbox"/> private <input type="checkbox"/> public address: 402 7th Street West, Roundup, Mt.	Roll # A5 Frame # 18

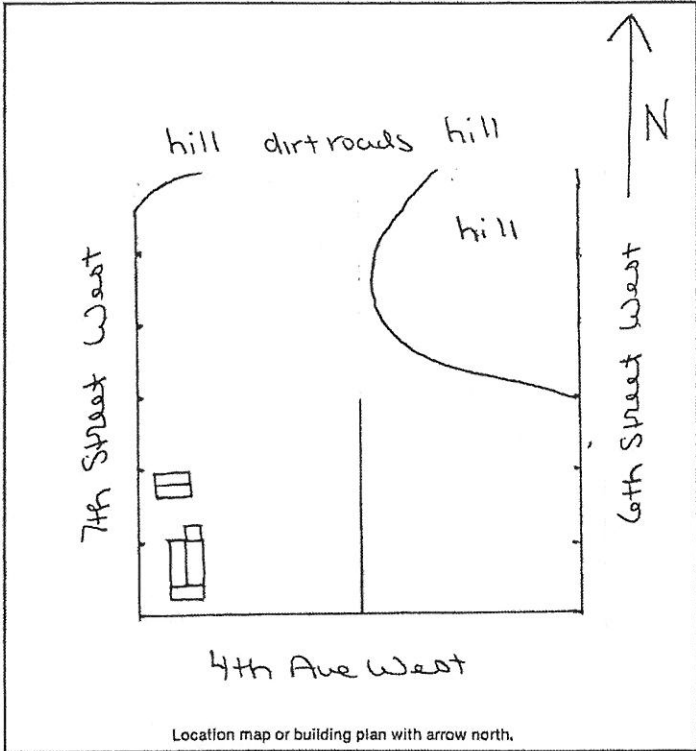
This rectangular one-story, wood-frame residence has a gable roof, a shed roof full enclosed porch and a shed roof enclosed back addition. Other features include boxed partial gable returns, enclosed eaves, small row 1/1 double-hung windows in the porch, one-, two-, and three-light fixed windows in the rear, various size 1/1 double-hung windows. The roofing is asphalt shingles. It has wide aluminum siding and a cement foundation. There is a large exterior steel sided chimney to the east. To the north is a rectangular wood-frame garage with double rising wood panel doors, wide aluminum siding, and cement foundation.

This remodeled house is located in a block of mobile homes, remodeled houses, and two original residences. This house has been enlarged and the front porch has been added. Use of various modern windows and modern siding and the remodeling have caused loss of integrity of materials and design.
