MONTANA HISTORICAL AND ARCHITECTURAL INVENTORY

Legal Description: Block 8, Lots 5 & 6, Steen Addition	
Address: 403 Sixth Street West	
Ownership: name: Herbert L. and Frances Newton	
<input checked="" type="checkbox"/> private <input type="checkbox"/> public address: 403 Sixth Street West, Roundup, Mt.	Roll # A5 Frame # 16

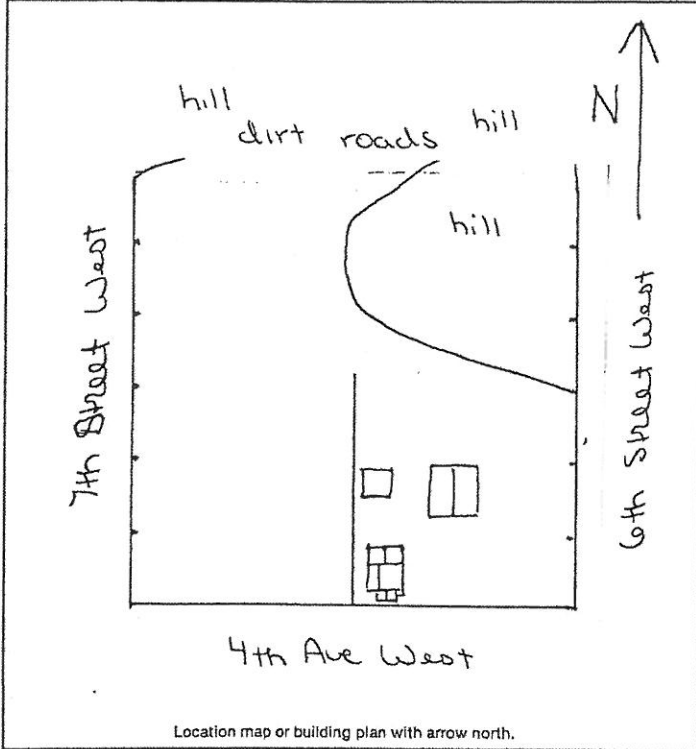
This rectangular log house with tar chinking and log corner boards has a steep pitch gable roof with a shed roof extension to the east, a steep pitch gable enclosed entryway and a newer gentle pitch gable rear addition. Other features include an interior brick chimney, wood roof shingles, enclosed eaves, and exposed rafters on the gable entry, 6/6 double-hung, 6/6 horizontal fixed and 6/6 horizontal slide windows are set in wood surround with sills in the logs. There is a cement foundation with an angled 1/1 fixed window set in it on one side of the entry and a short foundation protrusion with pent roof of wood shingles, and two three-light fixed windows on the east side of the entry. The modern log rear addition has 1/1 slide windows in wood surround, exposed rafters, asphalt roofing, and a cement side step.

To the rear is a rectangular one-story log double garage with wood frame gable roof, asphalt roofing, wood and glass panel garage double door (tiltup), no visible foundation.

This log house is located near the edge of town in a block of older homes, all remodeled. Despite the newer log addition this structure retains integrity of design, materials, and craftsmanship.
