# MONTANA HISTORICAL AND ARCHITECTURAL INVENTORY

Legal Description: <u>Block 19, Lot 6, Northwest Townsite Second Addition</u> Address: <u>406 Fourth Street West</u> Ownership: name: <u>Alvin E. and Helen R. Mock</u> <input checked="" type="checkbox"/> private <input type="checkbox"/> public address: <u>406 Fourth Street West, Roundup, Mt.</u>	Site # _____

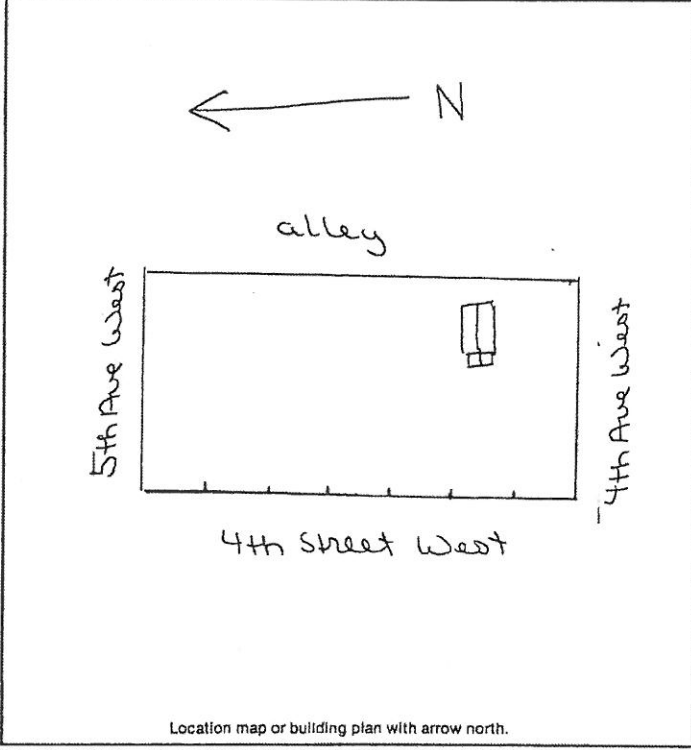
Roll # <u>A12</u> Frame # <u>18</u>

This one-story wood frame rectangular garage has a gable roof with gable roof front addition. Other features include interior brick chimney, wood roof shingles, exposed rafters, purling, 1/1 double-hung rectangular fixed windows, multilight front door, narrow overlap siding with corner boards. The interior of the building has been gutted and a large rising wood panel garage door attached to the back. This is a contributing structure.

This building is located in a middleclass residential neighborhood of predominantly older remodeled homes. This little house-garage has lost integrity of design. But the narrow overlap siding, purlins, and windows still retain integrity of materials and craftsmanship.
