MONTANA HISTORICAL AND ARCHITECTURAL INVENTORY

Address: 409 5th Street West

Date of Construction: 1920 estimated documented

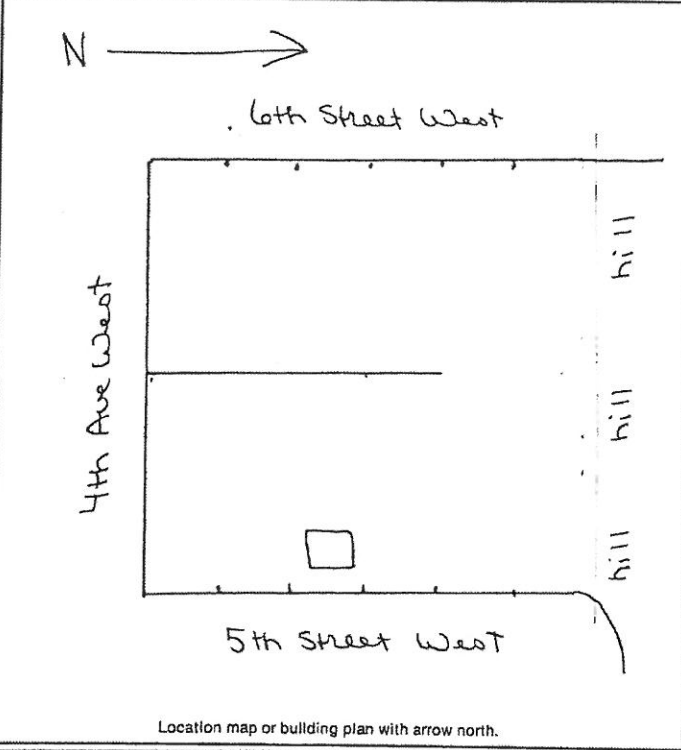
Roll # **A12** Frame # **39**

A rectangular one-story wood-frame residence with gable horizontal roof, beveled board siding (with end boards), large rear shed roof extensions and concrete foundation. Gable roof has exterior brick chimney, wood shingles, eaves with fascia. Windows are wood frame, double hung 1/1 with wood surround.

Front door has wood frame panels with one light and wood surround. Front porch consists of wood stoop, and corrugated plastic awning with 2 X 4 wood support posts and railing. Rear shed roof extension has masonite shake siding and composition sheet roof.

This small residence is located in a half block of other small older residences. It possesses integrity of location and setting but large rear addition to residence and its use of masonite siding have caused some loss of integrity of design and materials.
