MONTANA HISTORICAL AND ARCHITECTURAL INVENTORY

Legal Description: Block 11, Lot 4, Steen Addition

Address: 409 1/2 Fifth Street West

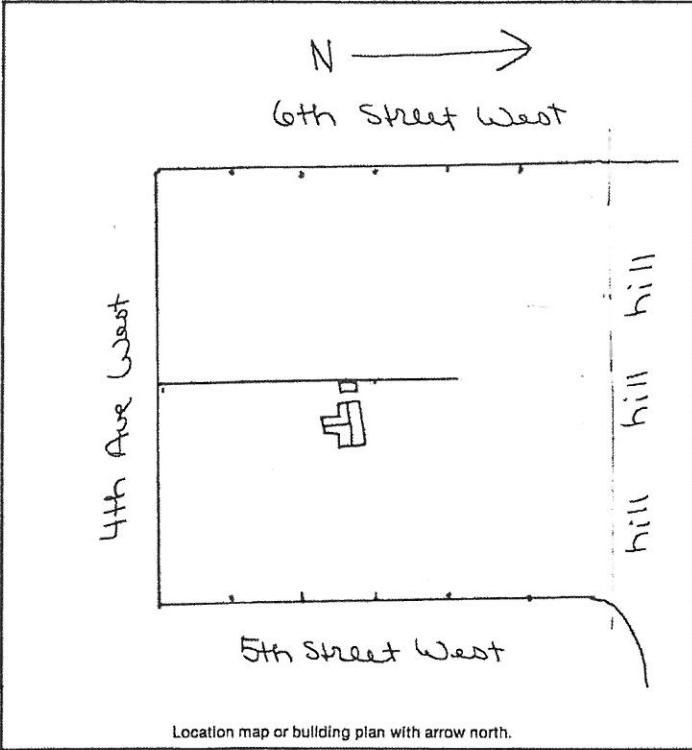
Roll # A12 Frame # 30

A one-story T-shaped wood-frame residence with intersecting gable roofs, stucco siding, enclosed front porch, and concrete foundation. Roof has interior brick chimney, composition shingle and sheet siding. Gable end has crown molding. Windows are wood frame, double hung 1/1 and fixed pane, some with wood surround trim. Front door is wood frame, with panels and lights, and wood surround. Front porch awning is flat with composition sheet roofing, and upper and lower diagonal support braces.

A rectangular, wood-frame shed, with shed roof, vertical board and wood shingle siding, with two wood-frame doors and wood shingles and sheet metal roof is located at rear of property.

This is a contributing structure.

This small residence is located in half block of small, older residences. It possesses integrity of location and setting, but appears to have had at least one addition.
