MONTANA HISTORICAL AND ARCHITECTURAL INVENTORY

Legal Description: Block 18, W $\frac{1}{2}$ of Lots 4 & 5, Northwest Townsite Second Addition Address: 410 Fifth Street West	Site #

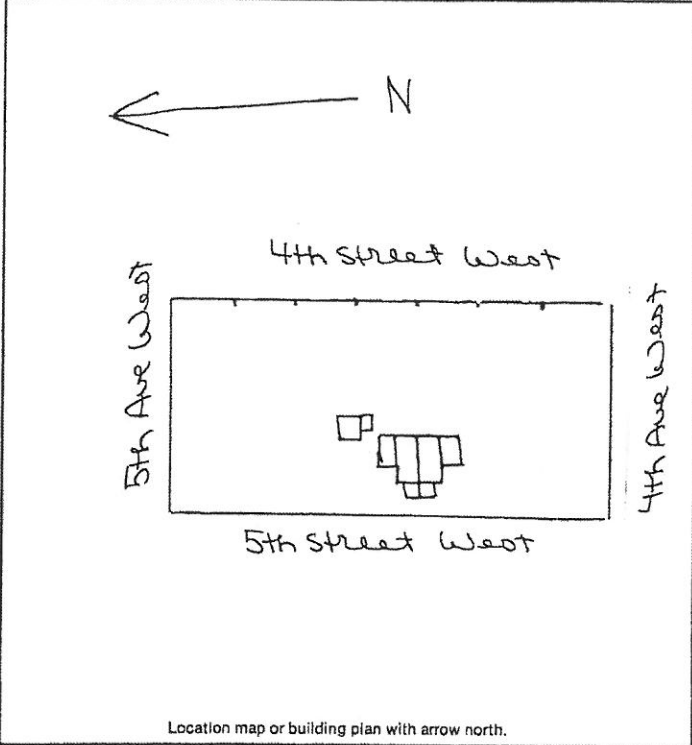
Location map or building plan with arrow north.

This one-story wood-frame T-shaped residence has a gable roof, a gable roof front addition and two side shed additions. Other features include interior brick chimney, extended eaves with exposed rafters, purlins, 1/1 double-hung windows, and no visible foundation. Modern materials include asphalt roofing, steel siding, aluminum storm windows and doors, 1/1 rectangular fixed windows, and stove pipe with ash guard.

There are two sheds facing each other forming a gable. They have horizontal wood board siding. There are no eaves on the north shed and casement hung vertical wood board garage doors. Extended eaves and exposed rafters on the south shed, with a wood panel door. No foundation visible for either building.

This house is located on an unpaved section of 5th Street West, in an area of small older cottages. Modern materials completely cover this home, causing loss of integrity of materials. And additions to the house over the years have caused loss of integrity of design.
