# MONTANA HISTORICAL AND ARCHITECTURAL INVENTORY

Legal Description: Block 11, Lot 3, Steen Addition

Address: 411 5th Street West

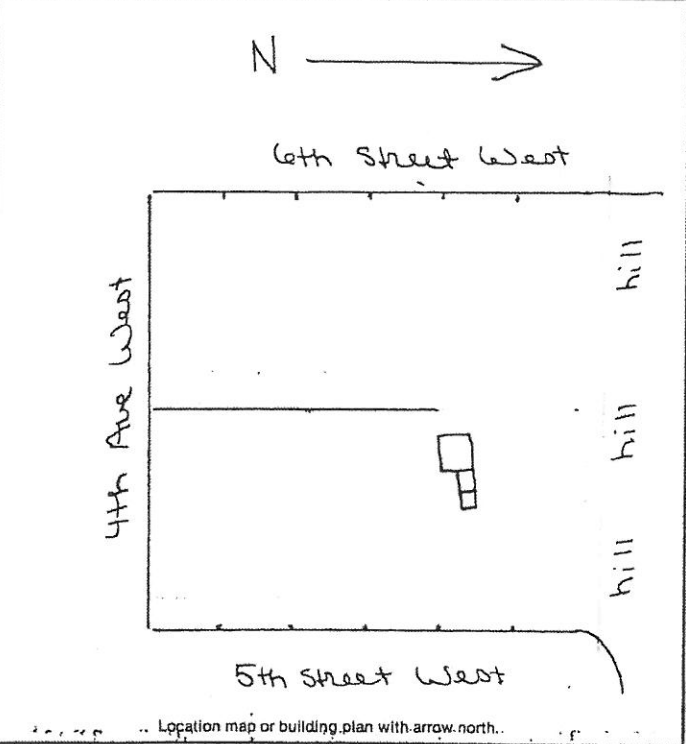
Roll # A12 Frame # 29

A rectangular, wood-frame structure consisting of three adjoining structures, main portion with gable roof and front shed roof extension with paired metal garage doors. Adjoining structures are sheds with shed roofs. Main structure has corrugated metal roof, horizontal beveled board siding with end boards and wood framed metal garage doors. Side sheds have horizontal board siding and wood frame doors (one with large pane, the other with panels) and fixed wood frame windows. Eastern most shed has short concrete chimney with stove pipe extension. This is a neutral structure.

**INTEGRITY:** Assess the degree to which the structure/site, and surrounding area accurately convey the historical associations of the property. This structure is located in a block of small, older residences. The apparent conversion of the main structure from a residence to a garage and the addition of the two sheds, both apparently added at different periods, have caused a loss of integrity of design, materials, and setting.
