MONTANA HISTORICAL AND ARCHITECTURAL INVENTORY

Legal Description: <u>Block 18, Lot 3, Northwest Townsite Second Addition</u> Address: <u>417 Fourth Street West</u> Ownership: name: <u>Luther G. and Ruth Egge</u> <input checked="" type="checkbox"/> private <input type="checkbox"/> public address: <u>417 Fourth Street West, Roundup, Mt.</u>	Site #

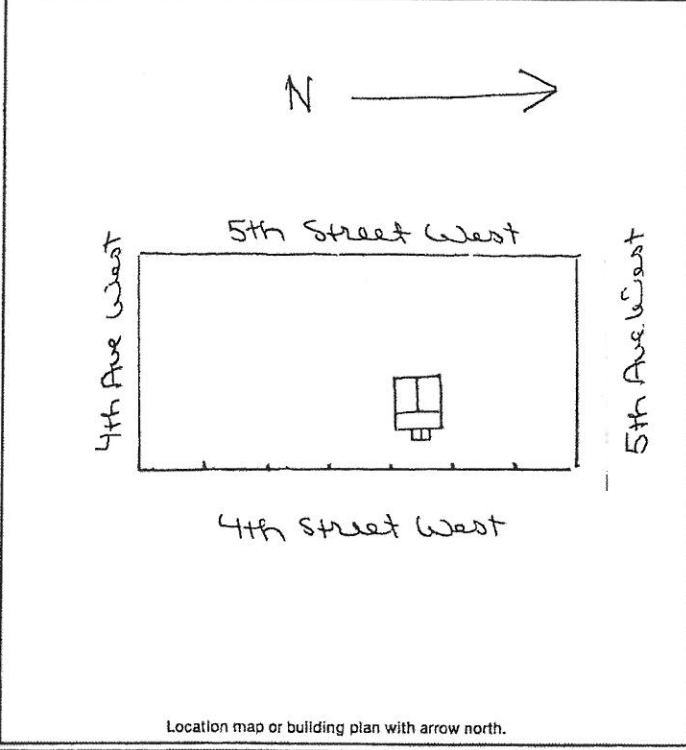
Roll # <u>A12</u> Frame # <u>21</u>
---	---	-------------------------------------

This square one story wood frame residence has a broad intersecting gable roof with a gable roof enclosed front entry. Other features include interior brick chimney, extended eaves, exposed rafters, diagonal braces, purlins, 1/1 double-hung windows and cement foundation. Modern materials include asphalt roof shingles, steel siding, a vertical wood paneled entry with multilight octagonal side windows, and aluminum storm door.

This house was originally "two shacks pushed together".
 This is a contributing structure.

This house is located in a neighborhood of older predominantly remodeled homes. This house has an enclosed front entry, and steel siding, causing some loss of integrity of design and materials. However, the basic integrity of design, (broad gable roof) materials (double-hung windows) and craftsmanship (rafters, purlins) is good, for the remodeled 1940's house.
