# MONTANA HISTORICAL AND ARCHITECTURAL INVENTORY

Legal Description: <u>Block 19, Lots 2 &amp; 3, Northwest Townsite 2nd Addition</u> Address: <u>4th Street West</u> Ownership: name: <u>Donald W. &amp; Helen Byford</u> <input checked="" type="checkbox"/> private <input type="checkbox"/> public address: <u>Box 332, Roundup, Mt.</u>	Site # _____  Roll # <u>A12</u> Frame # <u>15</u>

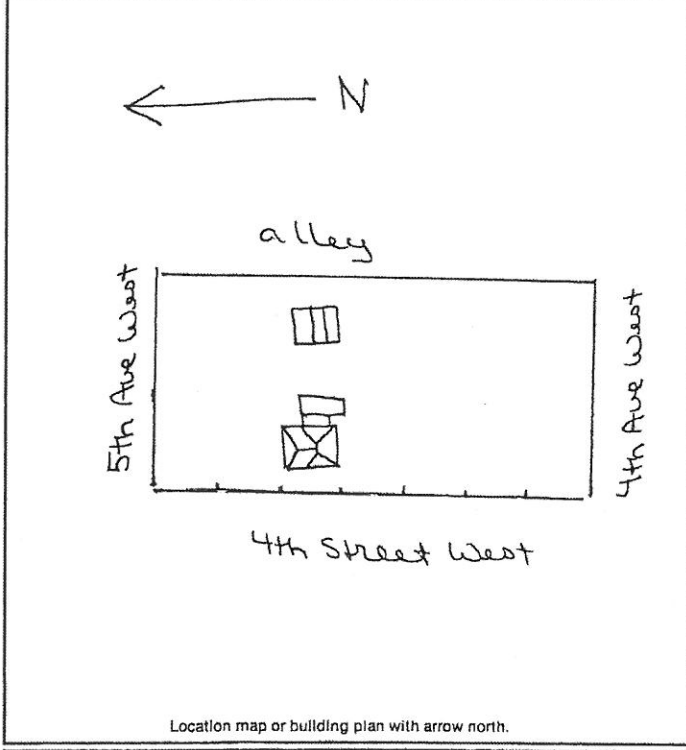
This rectangular, one-story, wood-frame residence has intersecting hip roof, a shed roof rear addition with attached carport and a small gable roof open entry. Other features include asphalt roof shingles, aluminum siding, various fixed and slide wood-frame rectangular windows, vertical board and batten siding around the front door, metal support posts and metal railing on a two-step cement stoop, and a cement foundation.

There is a gable roof garage to the rear with a side shed addition. Features include beveled edge wood siding, exposed rafters, asphalt roof shingles and fiber-glass rising garage doors.

This remodeled house is located in a neighborhood of remodeled older homes. The side hip roof addition and the use of modern materials has caused a loss of integrity of design and materials.
