MONTANA HISTORICAL AND ARCHITECTURAL INVENTORY

Legal Description: Block 3, Lot 4; Park Addition

Address: Fifth Street West

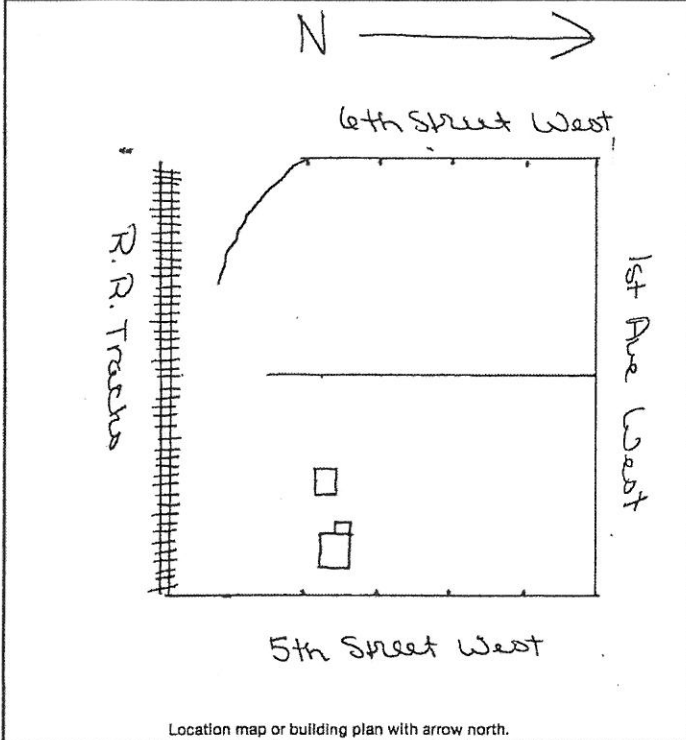
Roll # B3 Frame # 5

A one-story, wood-frame rectangular vacant residence with bowed, gently sloping roof, horizontal beveled wood siding, pier and post foundation. Roof is composition sheet and has two interior brick chimneys. Doors and windows are wood frame with wood surround trim and sills. Windows are double-hung 4/4. Door is wood with vertical panels, has a wood frame and wood surround trim. Shed roof extension is attached to the rear.

Rectangular, wood-frame shed, with shed roof, horizontal board siding, wood frame and wood surround trim is located at the rear of the property. Shed roof has composition sheets.

Buildings are located in a block of other small, older residential buildings in a working class neighborhood. Residence possesses integrity of setting, design and materials and conveys a sense of its historical associations.
