MONTANA HISTORICAL AND ARCHITECTURAL INVENTORY

Address: 602 Third Street East (near)

Date of Construction: 1918 estimated documented

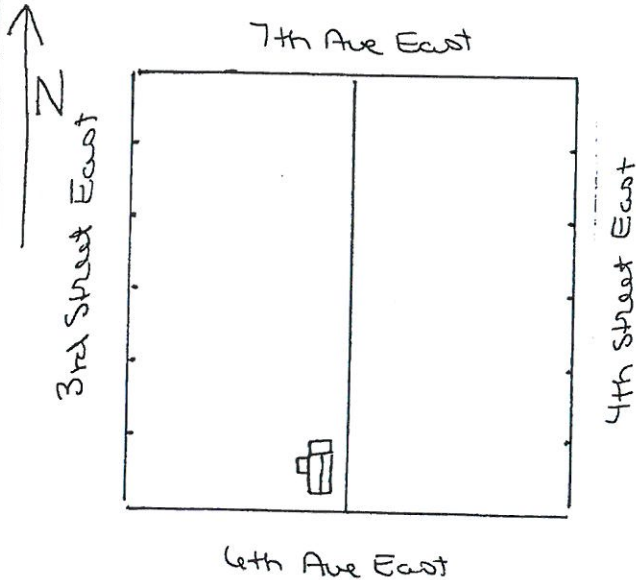
Roll # A10 Frame # 1

This rectangular, one-story, small, wood-frame residence has a gable roof and a side shed roof open porch and a rear shed roof addition. Other features include an interior brick chimney, exposed rafters, 4/4 wood slide rectangular windows, wood panel door, wood shingle siding. Modern materials include asphalt roofing, plywood shed roof back addition, and shed roof side porch of wood board flooring, wood board rail, and raw wood square porch supports.

This small house is located at the back of the property, no other houses around, on a hill overlooking prairie grass to the river. This house has lost some integrity of design and materials due to the back plywood addition and side porch reconstruction. Yet basic materials (shingles and wood slide windows) and craftsmanship (exposed rafters) is good.
