# MONTANA HISTORICAL AND ARCHITECTURAL INVENTORY

Site # \_\_\_\_\_  
 Legal Description: Block 1 Lots 9 & 10 Roundup First Addition  
 Address: 610 Third Street East  
 Ownership: name: Vernon Fletcher  
 private  public address: 610 Third Street East Roundup, Mt.

Historic Name: \_\_\_\_\_  
 Common Name: \_\_\_\_\_  
 Date of Construction: 1920  remodeled several times  estimated  documented  
 Architect: \_\_\_\_\_  
 Bullder: \_\_\_\_\_  
 Original Owner: \_\_\_\_\_  
 Original Use: Residence  
 Present Use: Residence  
 Research Sources:  
 abstract of title  city directories  
 plat records/maps  sewer/water permits  
 tax cards  obituaries  
 building permit  biographies  
 Sanborn maps — dates: 1912, 1920 area not mapped  
 Bibliography:  
 Interview: Mrs. Lottie Buckey  
 August 23, 1983  
 Mrs. Verna Fletcher  
 August 5, 1983  
 Chain of Ownership Cards  
 Clerk and Recorder Office

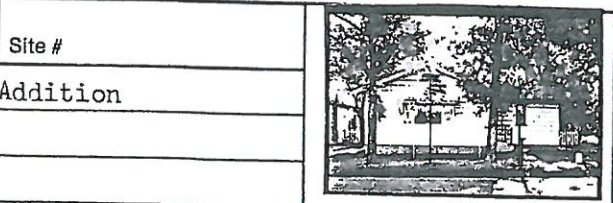
Roll # A13 Frame # 23

This one story wood frame residence has an intersecting gable roof, a hip roof rear addition and shed roof patio, and a small gable roof front door awning. Other features include interior brick chimney, elongated eaves, purlins, and exposed rafters, 1/1 double hung windows and a large rectangular front fixed window with four light side lights. There is a partial sandstone block foundation. Modern materials include asphalt roofing, masonite siding, a fiberglass patio roof to the rear, and a new cement foundation. Out-buildings include, 1. A large metal gable roof double car garage with a wood panel rising door, and a cement foundation. 2. A Wood frame gable roof garage with asphalt roofing, wood board siding, and vertical wood casement hung garage doors. 3. Three shed roof and gable roof garden sheds, wood board, bevel edged and overlap siding, assorted wood doors and multilight slide windows.

This house is located in a block of old and new residences, and across the ~~street~~ street from a 1/2 block of all modern structures. This house has been enlarged and added to many times. The front porch was removed and a cement slab poured. The front room enlarged and modern windows added. Remodeling has caused loss of design and materials integrity.
